# Impact of Evaporite Dissolution and Collapse on Highways and Other Cultural Features in the Texas Panhandle and Eastern New Mexico

Geological Circular 81-4

1981

Bureau of Economic Geology  
W. L. Fisher, Director  
The University of Texas at Austin  
Austin, Texas 78712

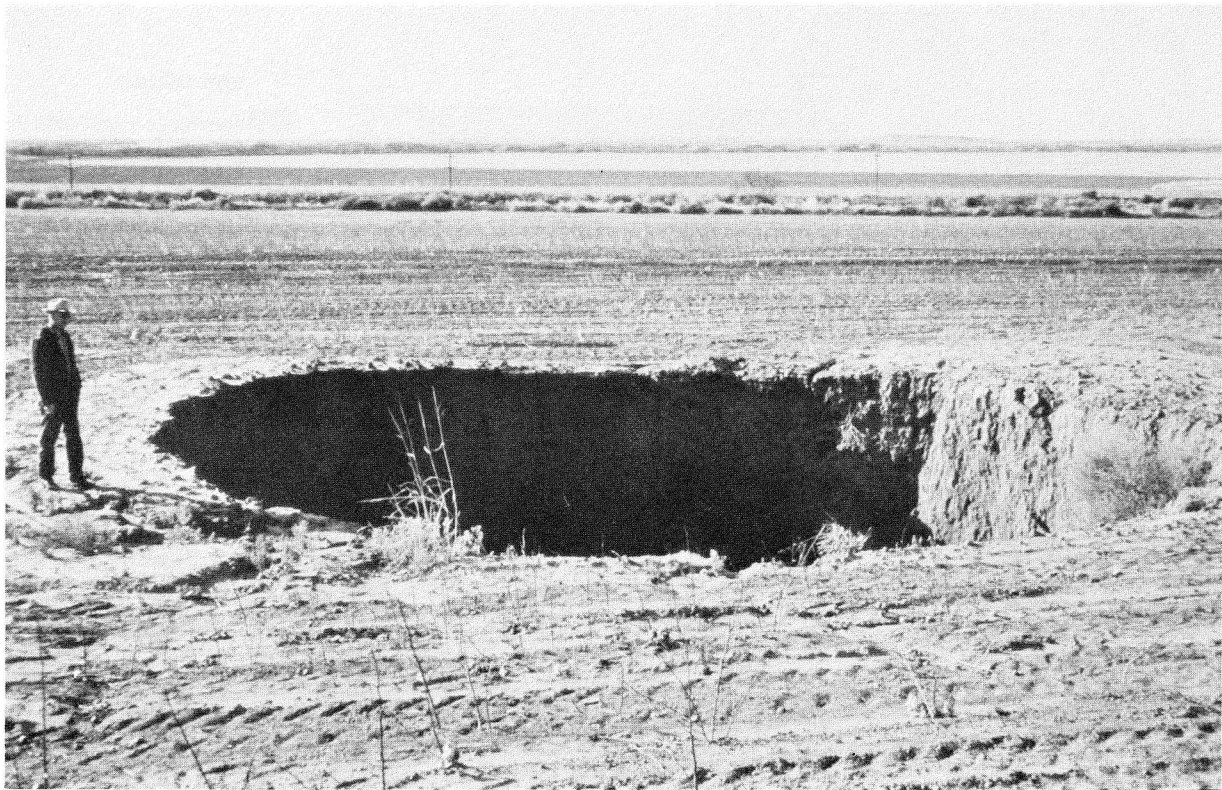
Figure 5. Sinkhole located near U.S. Highway 287, 6.4 km (4 mi) northwest of Estelline in Hall County, Texas. The feature is approximately 10.6 m (35 ft) wide and 7.5 m (25 ft) deep.

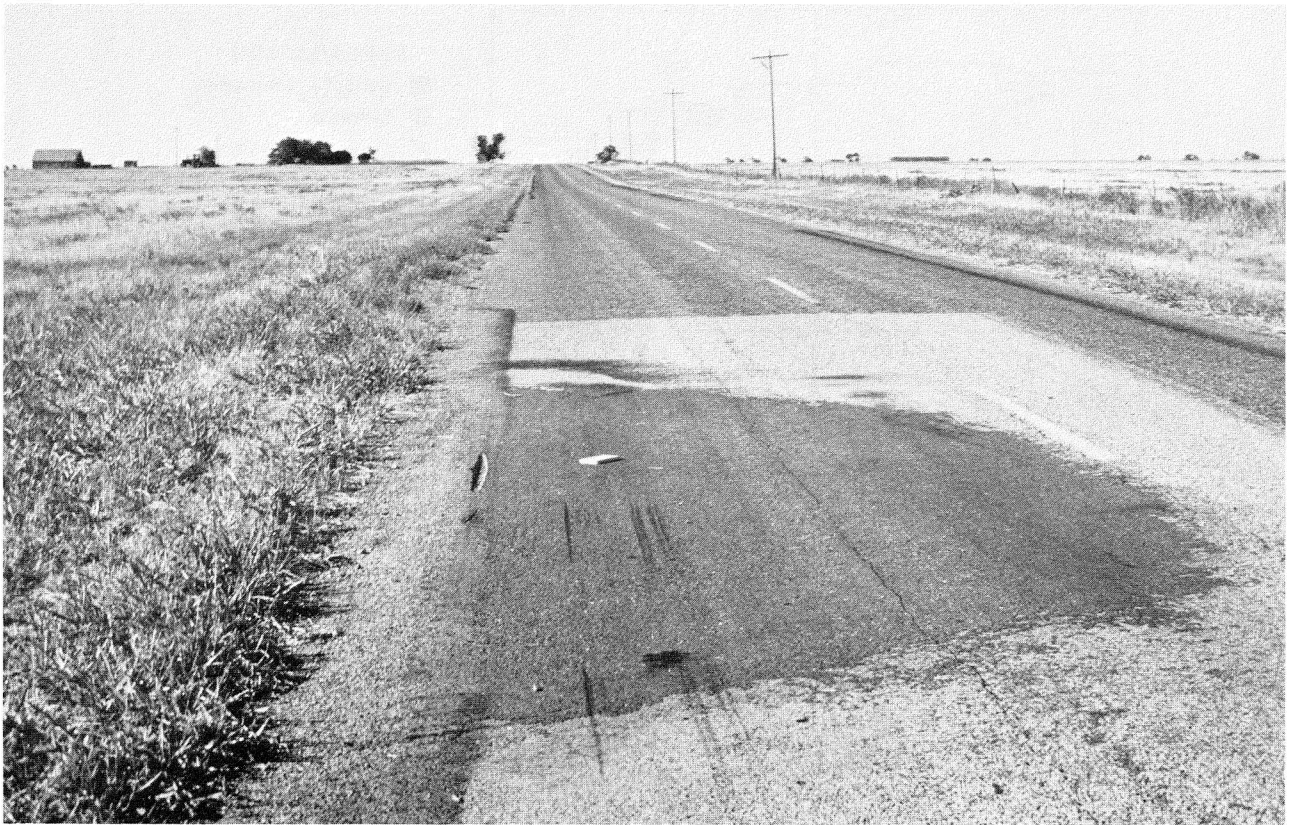
Figure 8. View south along FM 1033 in Childress County showing collapse depression. The depression affects most of the northbound lane and extends into the borrow ditch. Different shades of road patches at this site attest to the history of subsidence.

approximately 9.1 m (30 ft), and the swale has developed since the highway was built in June 1968. Evidence of previous subsidence at this site is shown by the badly faulted old road (formerly U.S. Route 66), which now parallels Interstate 40 on the south. The old faulted road and the depressed sections of Interstate 40 are generally aligned in a northeasterly direction. A sinkhole measuring 3.3 m (10 ft) in diameter occurs in a roadcut immediately west of this site, which further confirms that the processes of dissolution and collapse are active in this area.

In the central part of the study area, a small collapse depression was identified on FM 1033 south of Kirkland, Texas, 1.6 km (1.0 mi) north of the Childress-Cottle county line (fig. 7; site 9). Diameter of the feature is about 6 m (20 ft); about half of the depression affects the pavement surface. Several generations of road patches attest to the fact that collapse has occurred over several years. Repairs to this section of the highway have been made regularly since 1966. Within the collapse depression, a smaller sinkhole in the highway borrow ditch collapses periodically and must be filled (fig. 8). The effect on the highway itself, however, is mainly from the collapse depression.

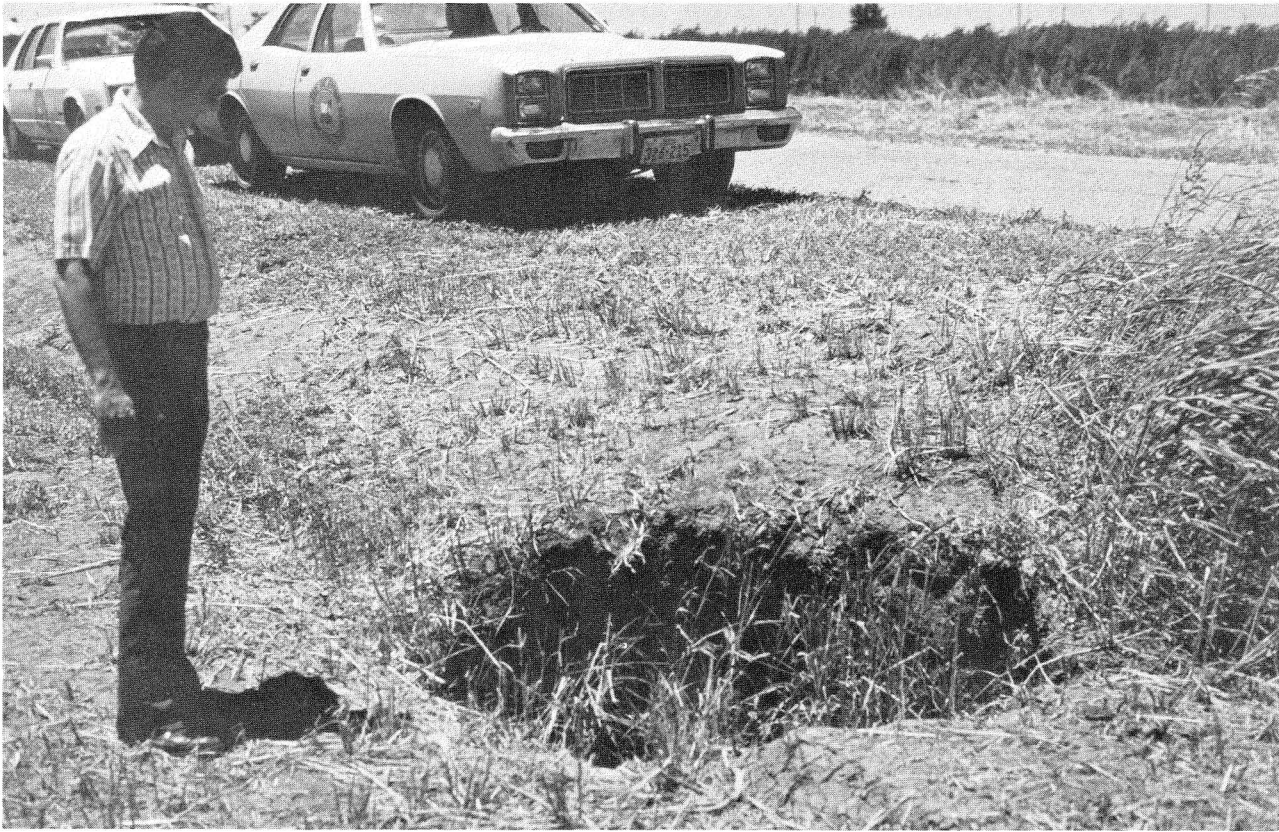
Figure 9. Sinkhole in the borrow ditch adjacent to FM 1034 west of Arlie, Texas. The sinkhole is approximately 0.9 m (3 ft) deep and 1.2 m (4 ft) wide. Sinkholes of this type are common along highways in the Texas Panhandle.

Numerous smaller sinkholes, commonly called "gyp sinks" by highway personnel, are recognized in borrow ditches throughout the study area (fig. 7; sites 1, 4, 8, 10, 11, and 12). Many sinkholes exist in outcropping gypsum bedrock (fig. 9). Somewhat

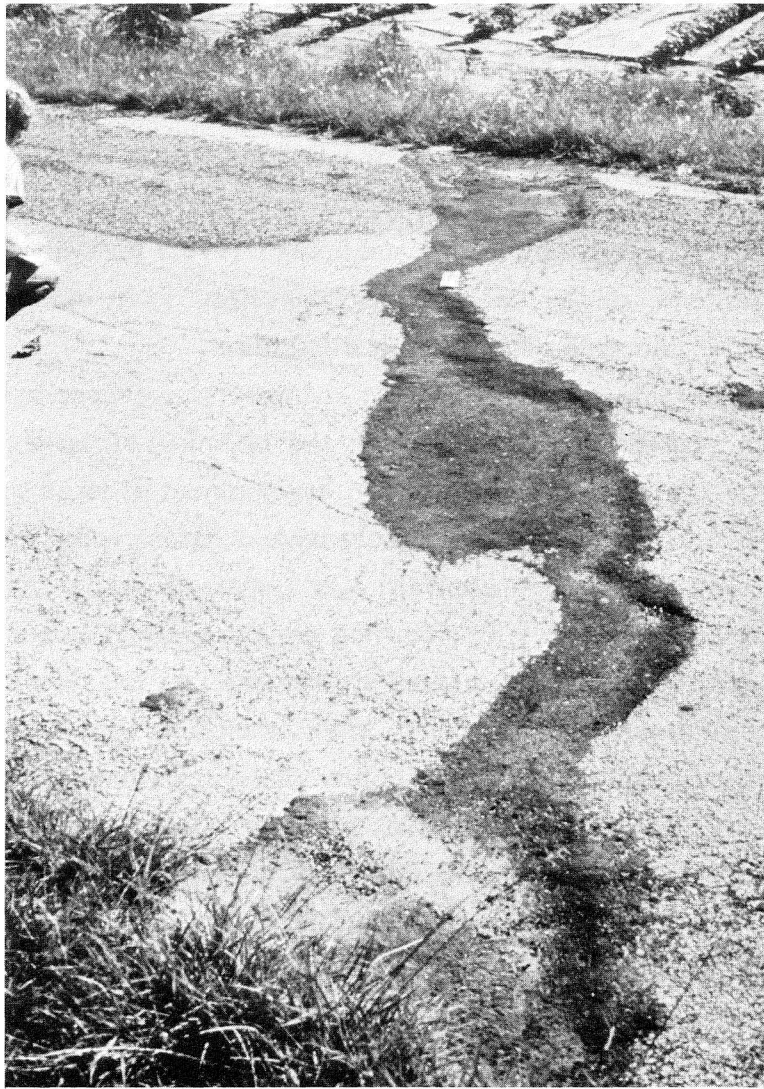
Another major impact of dissolution and collapse on highways is faulting. The best example of faulting occurs along FM 2639, 19 km (12 mi) west of Estelline in Hall County, Texas (fig. 7; site 7). Here, six faults trending N 25° E to N 50° E were recognized by displacement along the faults measuring from 1 to 4 cm (0.4 to 1.6 inches). Although only a few inches wide when formed, the fault plane (fig. 10) was 1.5 m (5 ft) deep. Repairs have been necessary on the road about three times per year since the fault appeared in 1979. Similar faults have been recognized near Memphis, Texas (fig. 7; site 6), and 9.6 km (6 mi) south of Lutie, Texas (fig. 7; site 5). The Lutie fault plane was nearly 0.9 m (3 ft) deep and the fault trace trended almost east to west across the northbound lane of U.S. Highway 83. It has since been filled and has not recurred.

Figure 10. Fault trending northeast across FM 2639 in Hall County. Left side of fault is depressed approximately 3 to 4 cm (1.5 to 1.8 inches) relative to the right side. Fault extends into the cultivated field.
