Geological Circular No. 92-2

Surface Fissures in the Hueco Bolson and Adjacent Basins, West Texas

Robert W. Baumgardner, Jr., and
Bridget R. Scanlon

Research funded by the Texas Low-Level
Radioactive Waste Disposal Authority under
Interagency Contract Number IAC(90-91)0268

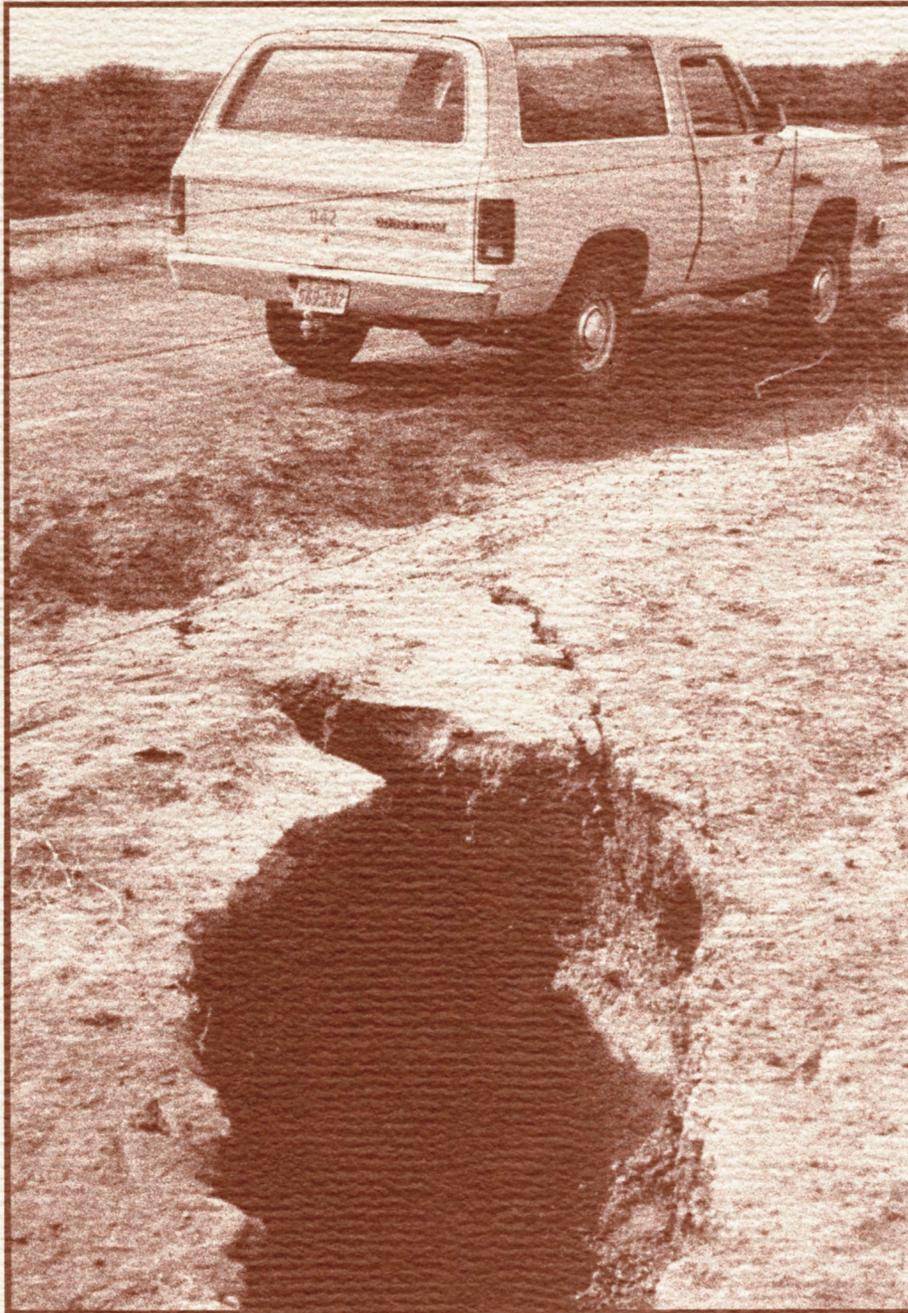
Cover photograph:

Fissure formed in Ryan Flat south of Valentine, Texas,
on April 21 or 22, 1990. For further information,
see discussion in text beginning on page 29.

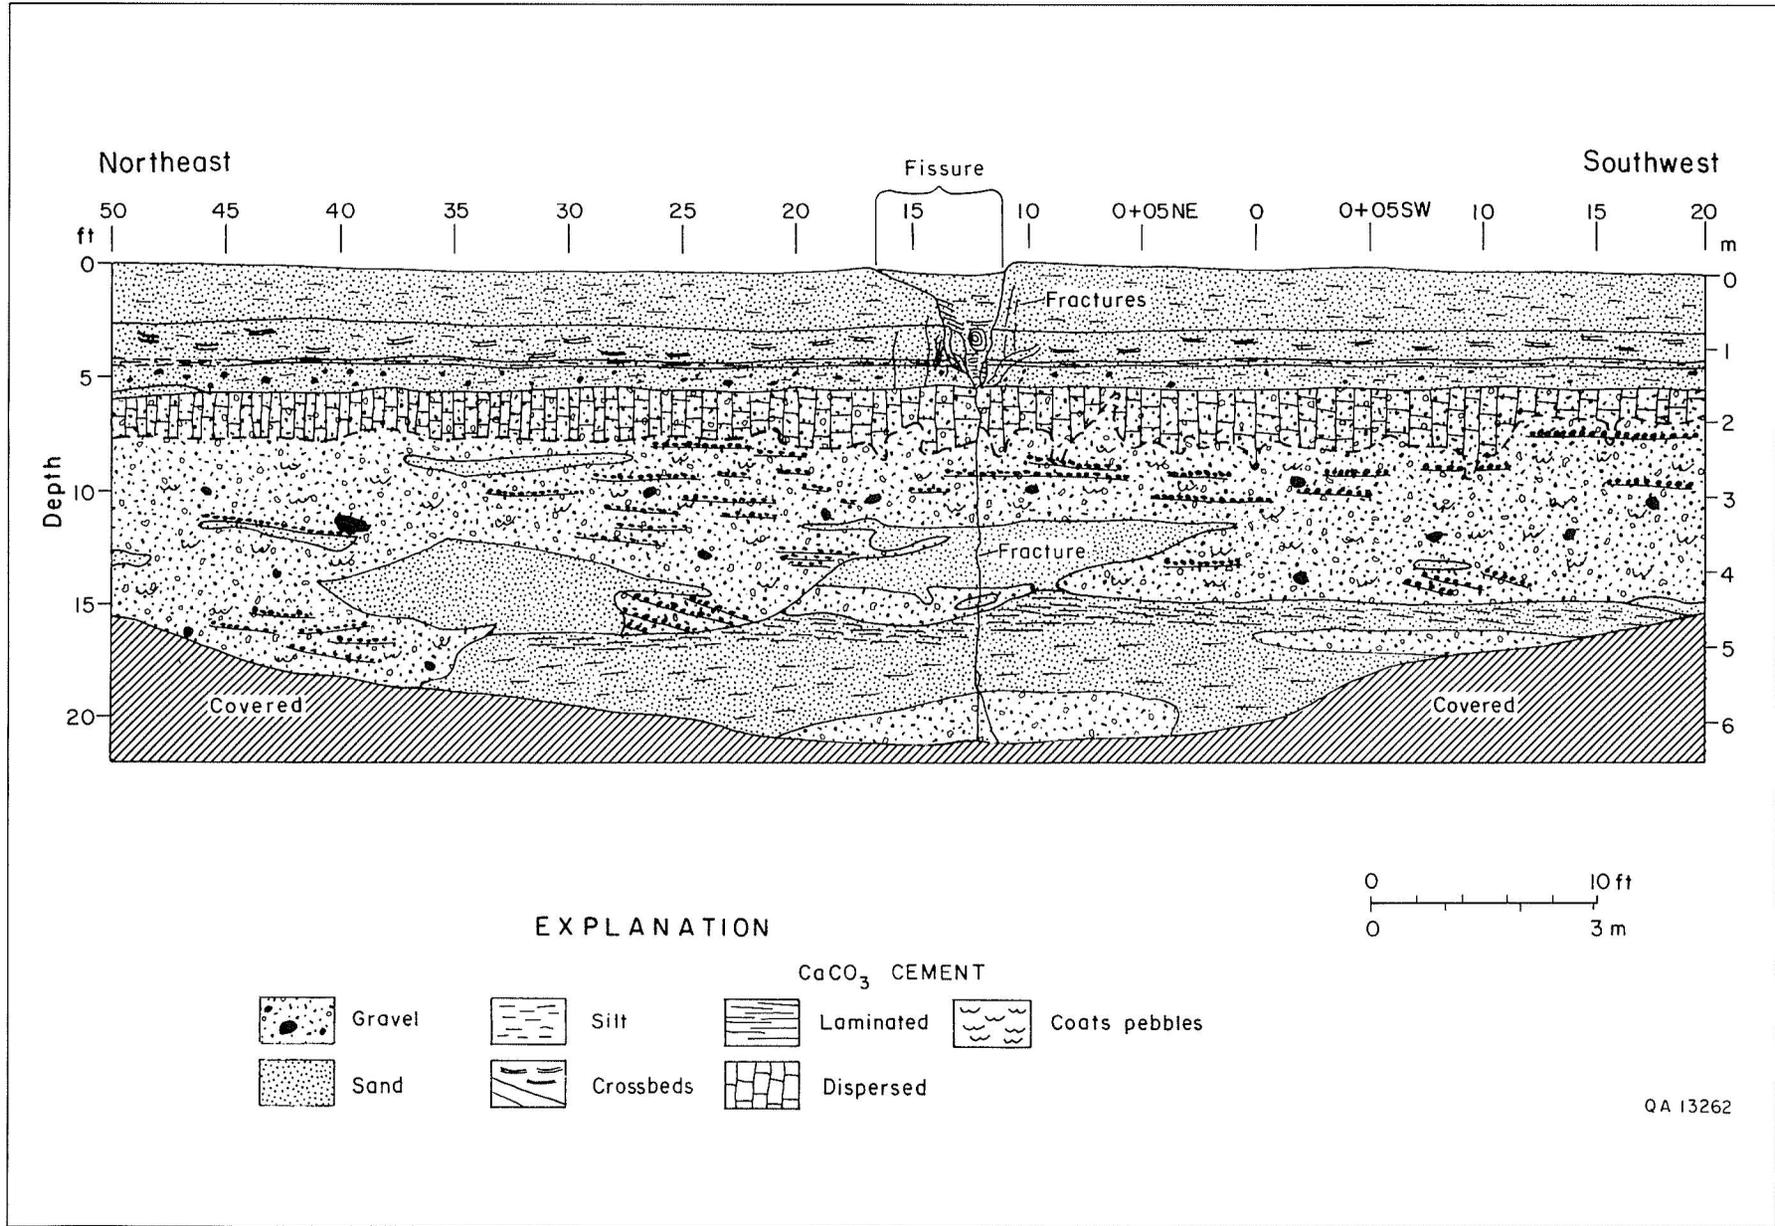
FIGURE 5. General view of southeast wall of trench 3 at fissure 1. The arbitrary horizontal coordinate system for trench logging, marked in 5-ft (1.5-m) intervals, is shown at top of figure. See figure 4 for location of trench.

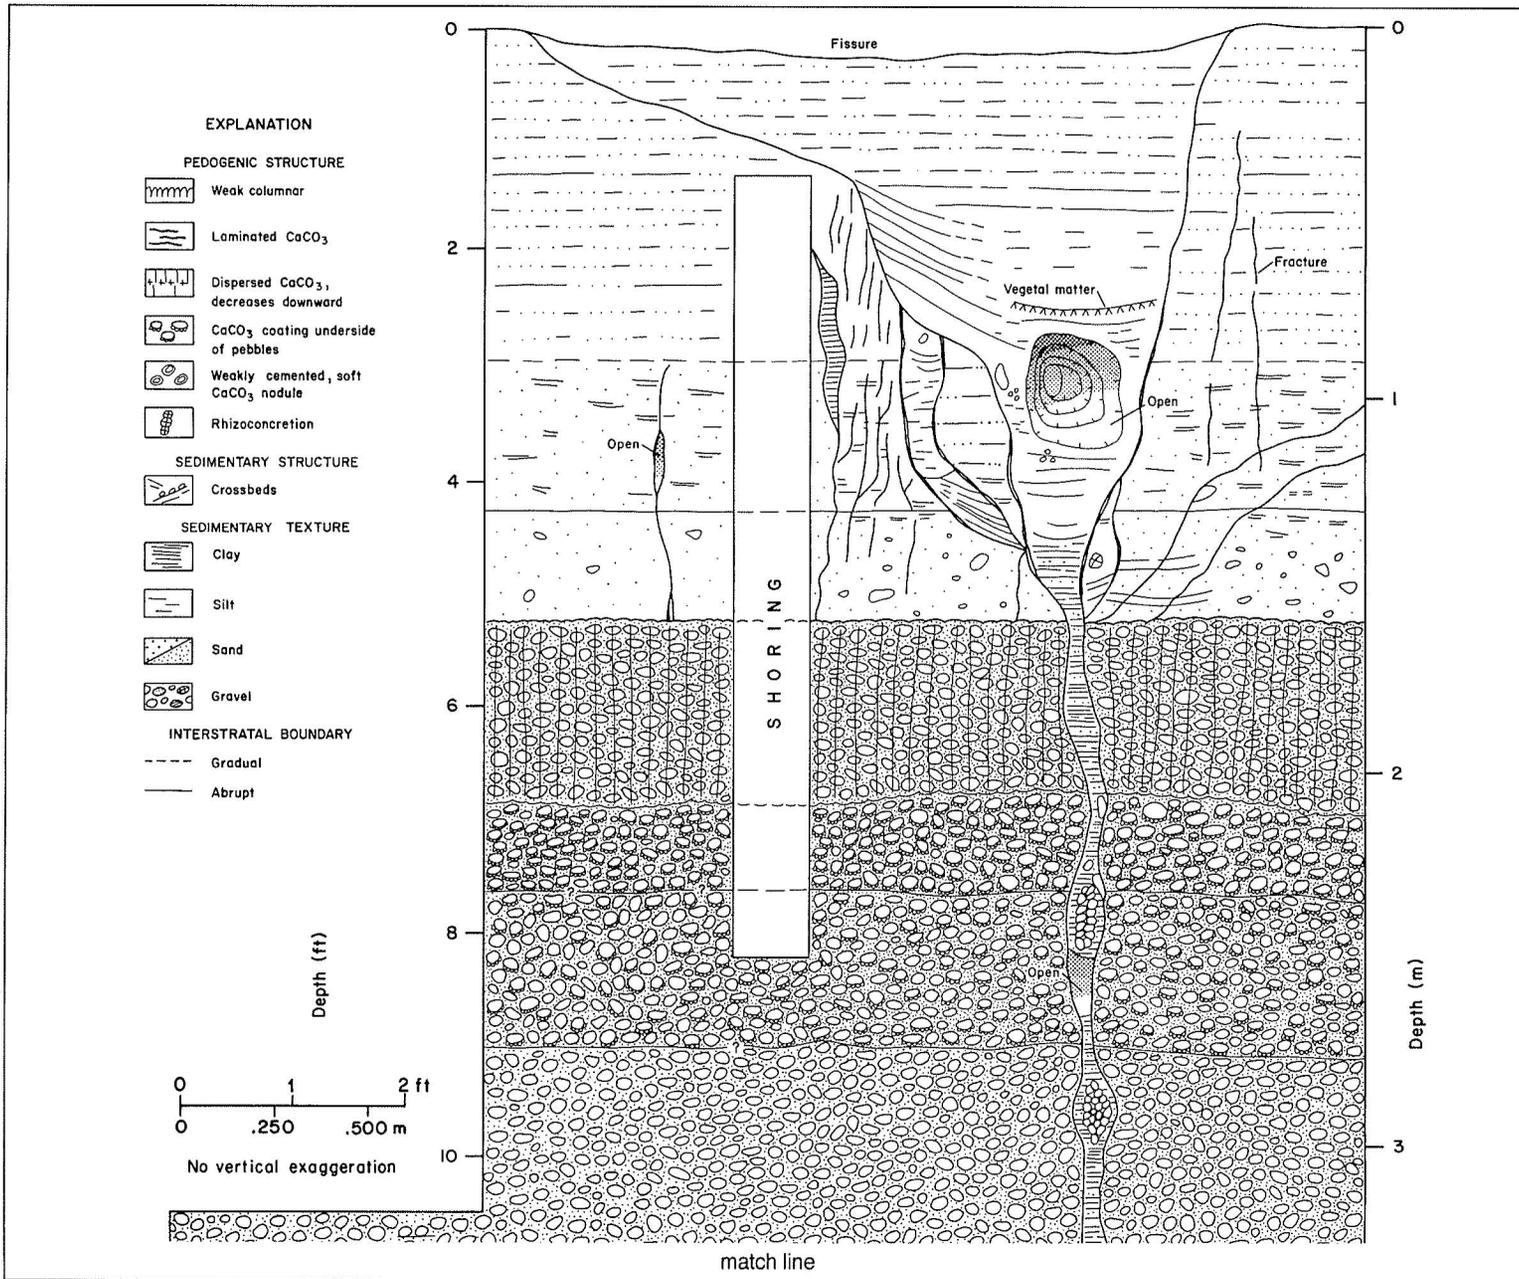
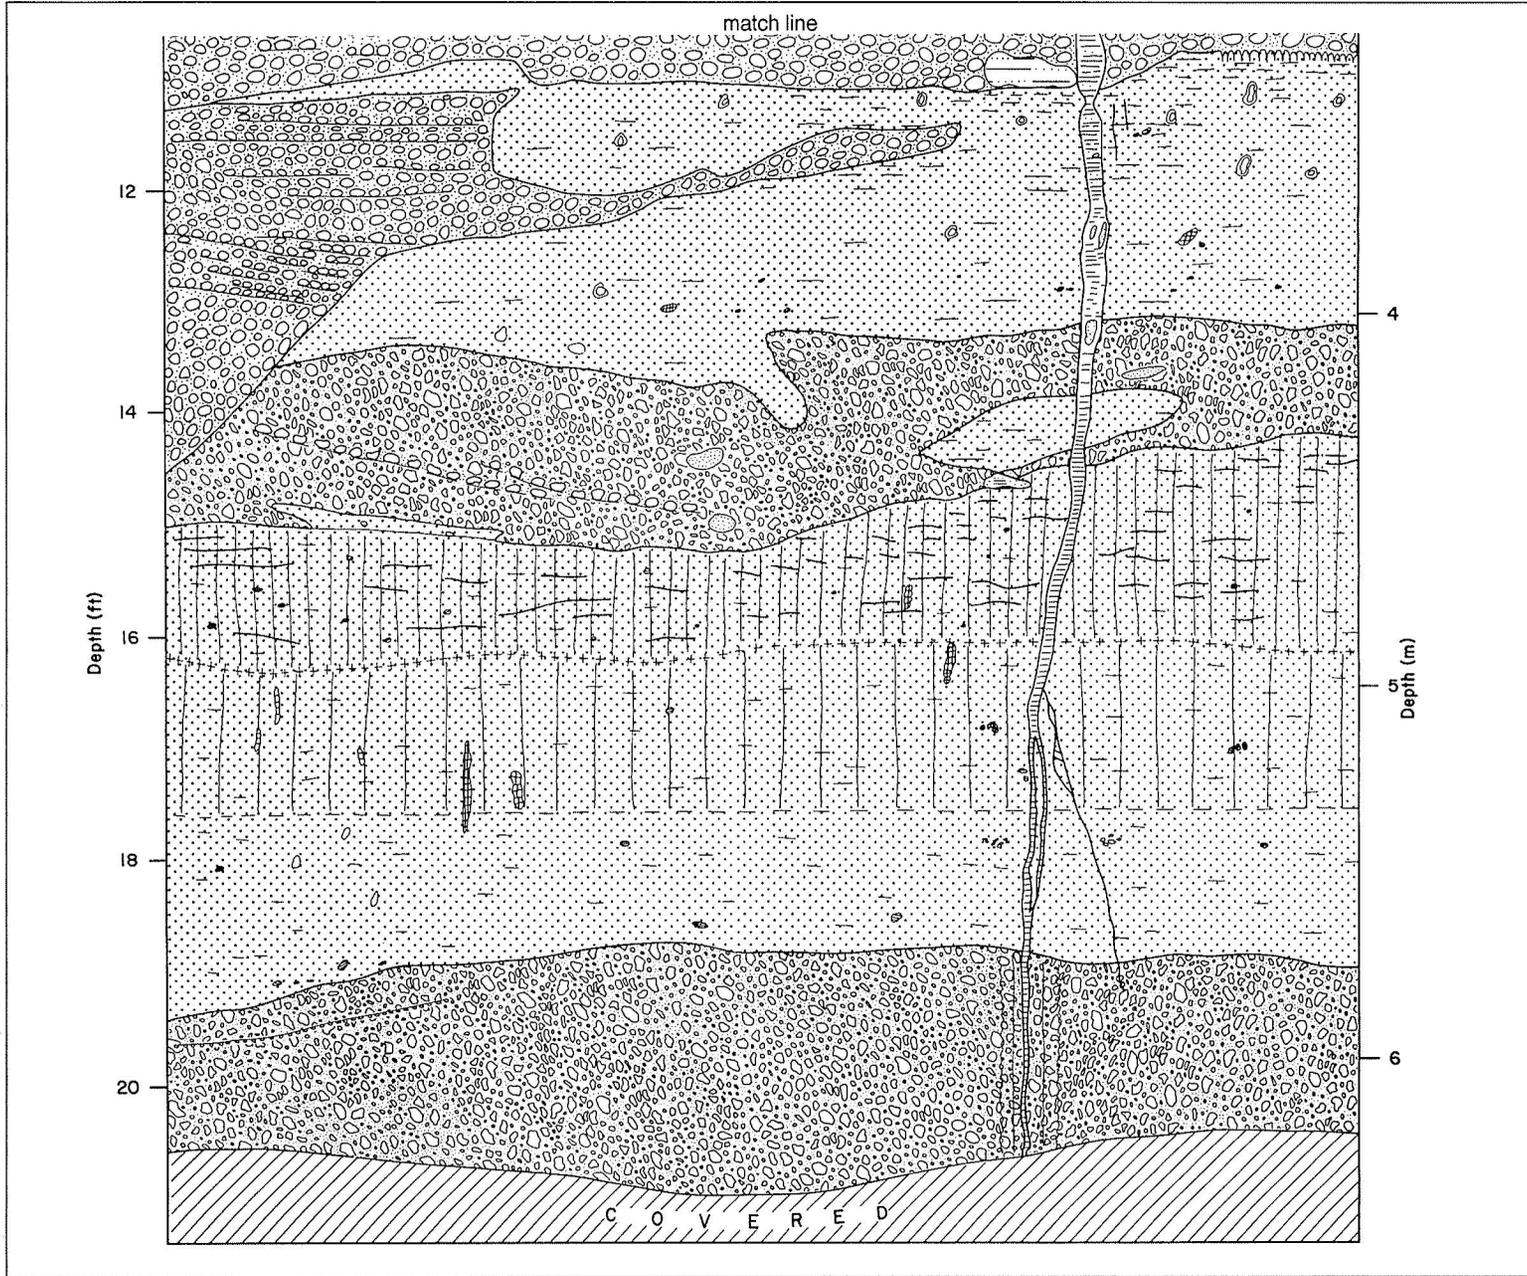
FIGURE 6. Detail of fissure 1 in southeast wall of trench.

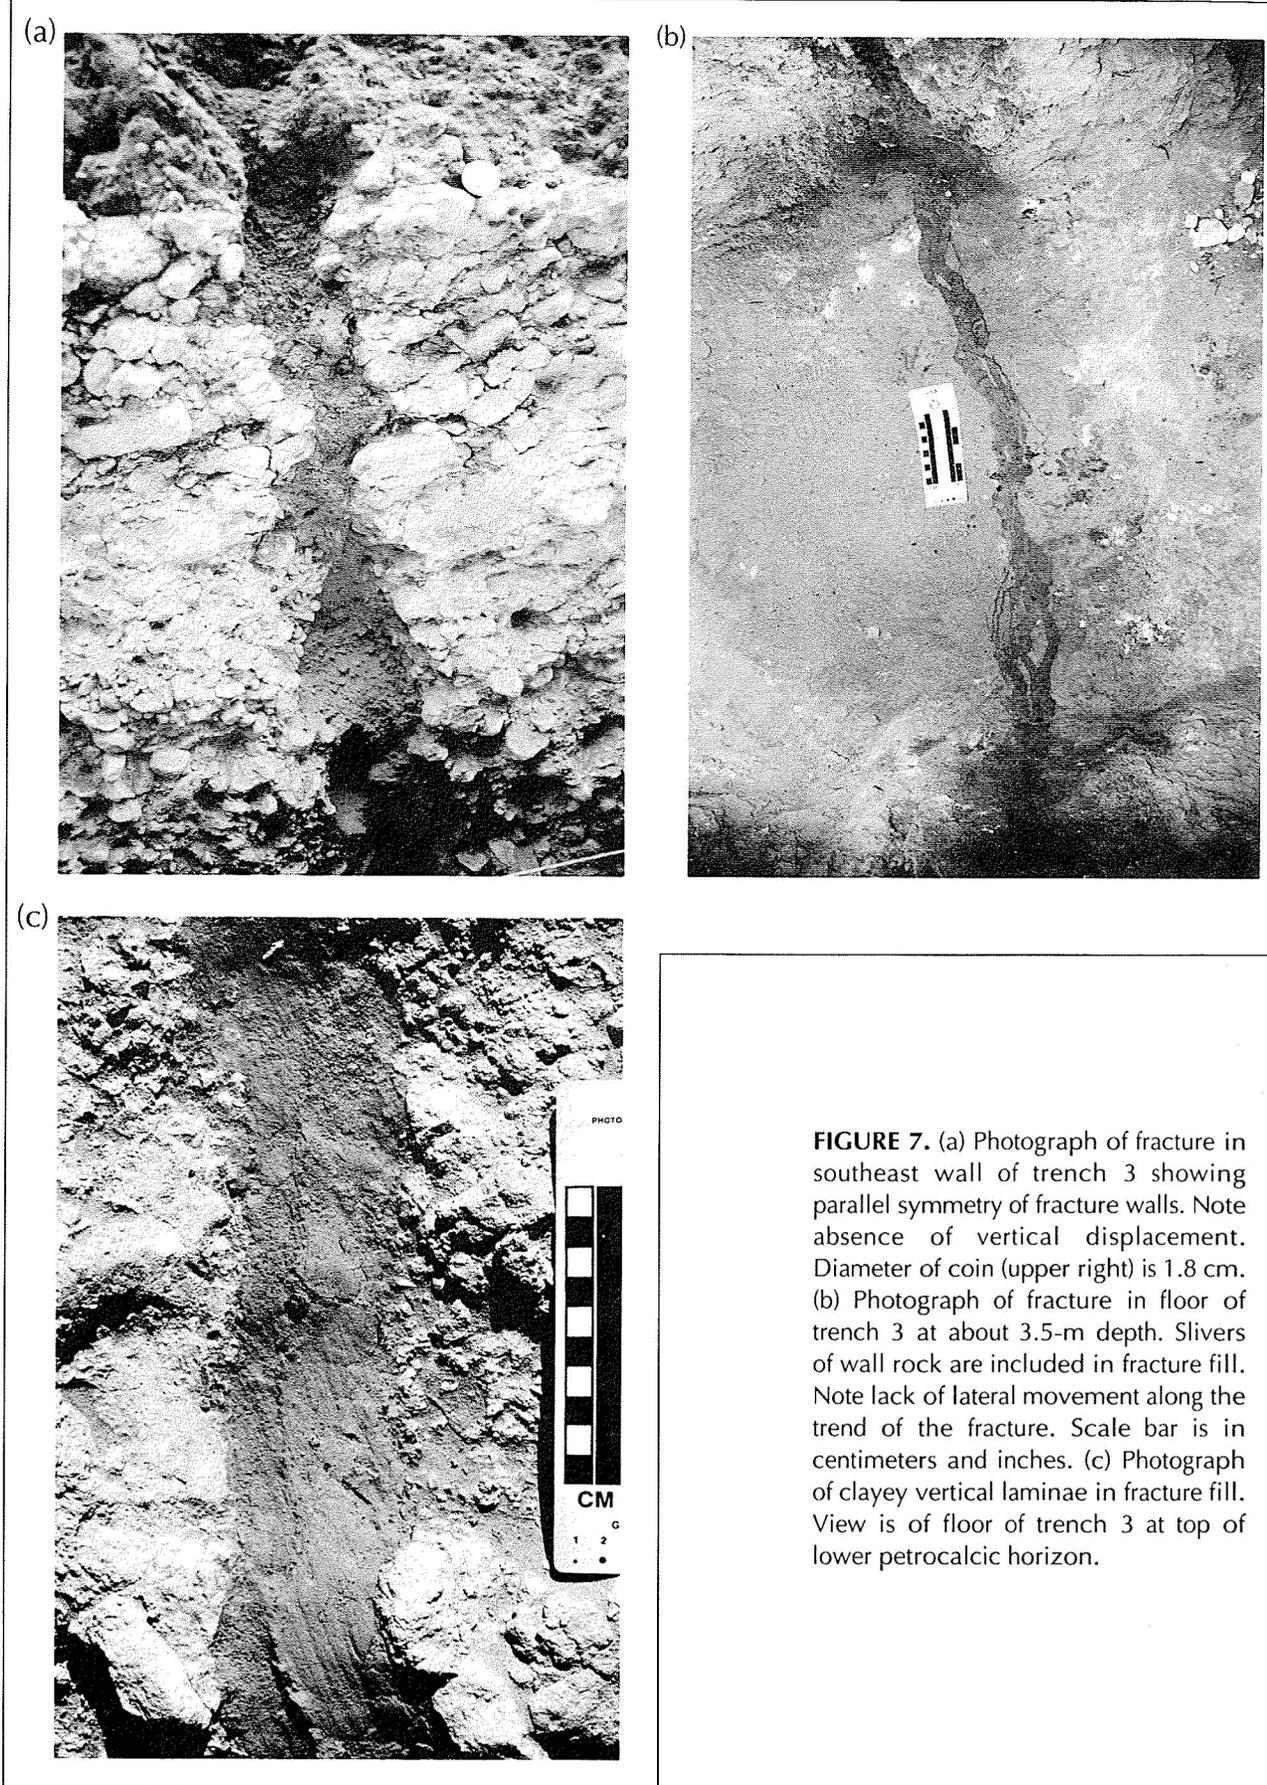
FIGURE 7. (a) Photograph of fracture in southeast wall of trench 3 showing parallel symmetry of fracture walls. Note absence of vertical displacement. Diameter of coin (upper right) is 1.8 cm. (b) Photograph of fracture in floor of trench 3 at about 3.5-m depth. Slivers of wall rock are included in fracture fill. Note lack of lateral movement along the trend of the fracture. Scale bar is in centimeters and inches. (c) Photograph of clayey vertical laminae in fracture fill. View is of floor of trench 3 at top of lower petrocalcic horizon.

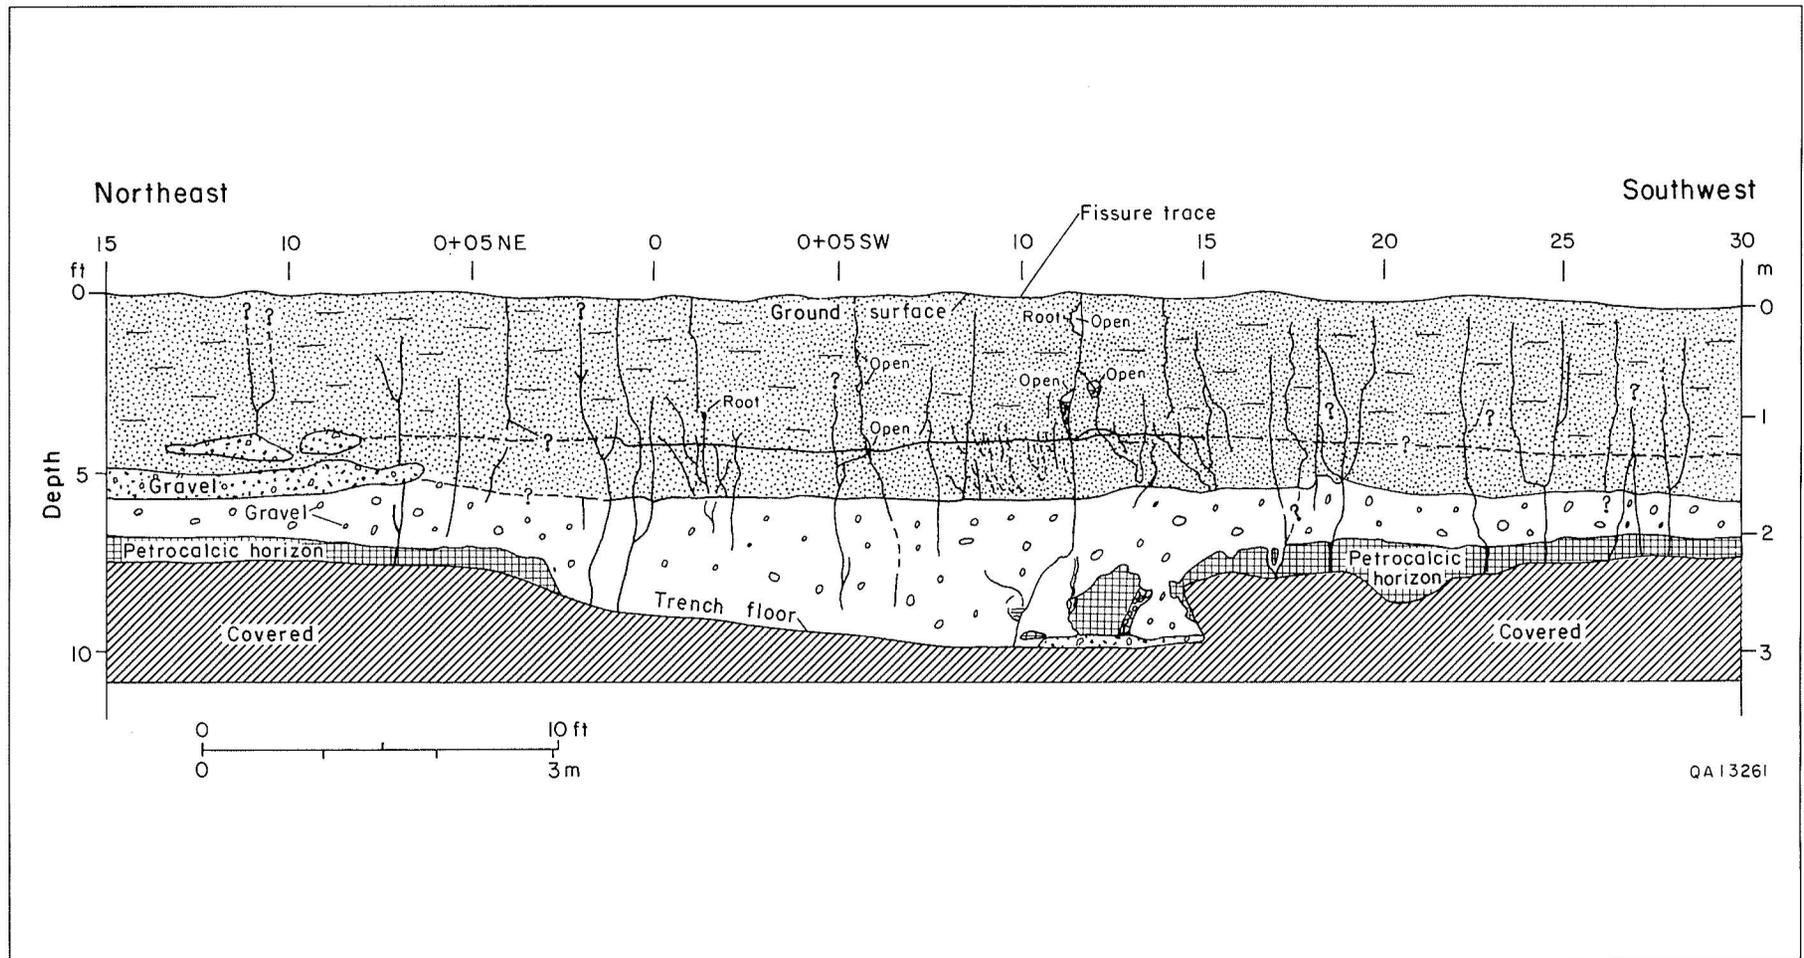
Numerous small, closed fractures between the fissure-bounding fractures in trench 4 are present in the crossbedded sandy unit above the massive gravelly sand (figs. 8 and 9; 1.5-m depth). They are more common here than farther from the trend of the fissure. Unlike the fissure-bounding fractures, these fractures branch upward. They are hairline fractures that are barely traceable, and all appear to be confined to this sedimentary unit.

FIGURE 8. General view of southeast wall of trench 4 at fissure 1. Detailed sedimentary data are omitted to emphasize fractures. Although the fissure is not visible here, its interpolated position between adjacent collapse features (to the northwest and southeast) is shown. See figure 4 for location of trench and figure 9 for sedimentologic detail.

rubble zones upward into the overlying massive unit to within 60 cm of the surface. As with the fractures in trench 3, there is no offset across these fractures. The rubble zones consist of structureless sediment that is more silty than the adjacent crossbedded silty, fine to medium sand. Although they appear to terminate abruptly in the vertical wall of the trench, they probably continue up and down at some angle to the trench wall.

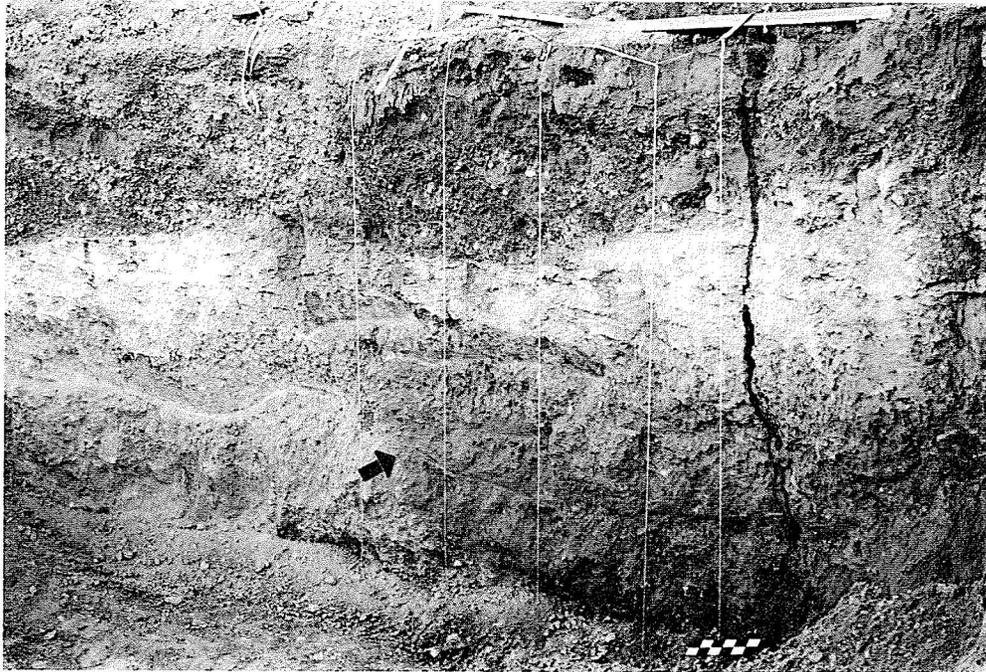
Soil-water bromide concentrations were high in the fracture fill to a depth of 2.2 m, whereas bromide concentrations were close to background values (zero) at a depth of 1.4 m in adjacent sediments (fig. 14c). Although the ponded area extended 1 m

FIGURE 13. Photograph of southeast wall of trench 3 after further excavation below level of ponding test (top of photograph). Ponding test was conducted before trench was deepened. Hanging strings mark approximate locations of sampling profiles for cross sections in figure 14. Edge of wetting front (arrow) is visible as dark zone convex toward the left.

from the fracture, high bromide concentrations were measured in soil-water samples collected 1.5 m from the fracture. No bromide was detected in the profile 2 m from the fracture fill. Bromide data indicate that the lateral movement of the infiltrated water in the coarse-grained material 0.7 to 0.9 m below the pond was less than in finer grained material above and below. The distribution of chloride was similar to bromide, except that background chloride concentrations were not initially zero (fig. 14d). The water content and solute data suggest preferential flow of water in the fracture fill relative to the surrounding sediments.

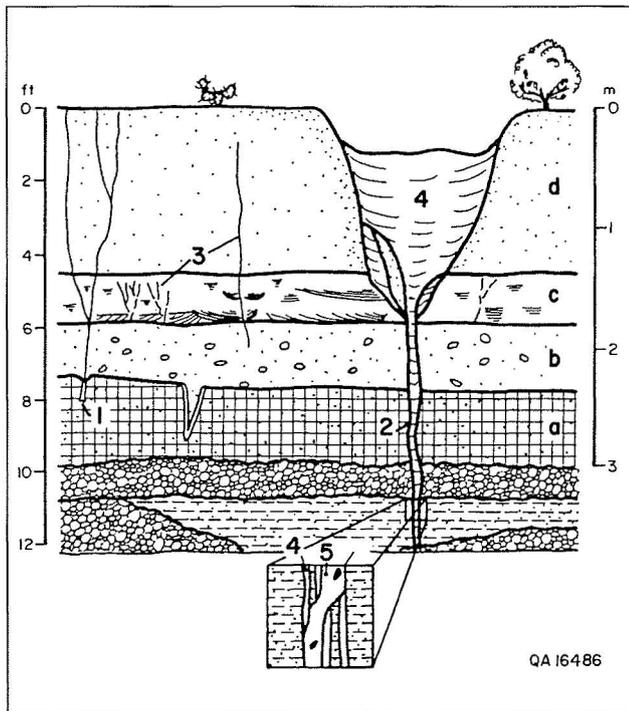
On the basis of aerial photographs taken in 1971 and 1985, collapse features at fissure 1 are inferred to have formed between 1971 (photographic scale 1:16,000) and 1985 (approximate scale 1:14,000). No collapse features are visible on the 1971 photographs, but they are present on the 1985 photographs. Although fissure 1 is visible, collapse features at fissures 2 and 3 cannot be seen on the most recent photographs (1989, scale 1:5,000), so their age is undetermined. No surface-collapse features appear at the relict fracture.

Fissure 1 appears to be older and at a more mature stage of development than fissures 2 and 3. Fissures 2 and 3 will probably follow similar patterns of development, although they may develop slower because they are in smaller drainage basins. Overland flow will continue to enlarge the fissures until the outlet for sediment is plugged; then they will fill

FIGURE 19. Schematic cross section of fissure 1. Development of the fissure is discussed in the text (p. 36). Symbols: (a) Stage III to IV petrocalcic horizon, (b) poorly sorted, massive gravelly sand, (c) crossbedded sand, (d) structureless silty sand, (1) fracture in petrocalcic horizon, (2) tension fracture, precursor to fissure, (3) other fractures, which may be caused by trenching, (4) sediment filling surface-collapse feature and (inset) fracture, and (5) fabric resulting from episodic fracture filling.
