Airborne and Ground Surveys of the April 2023 Daisetta Sinkhole, Liberty County, Texas

Open-File Report 23–1

April 12, 2023
Revised May 11, 2023

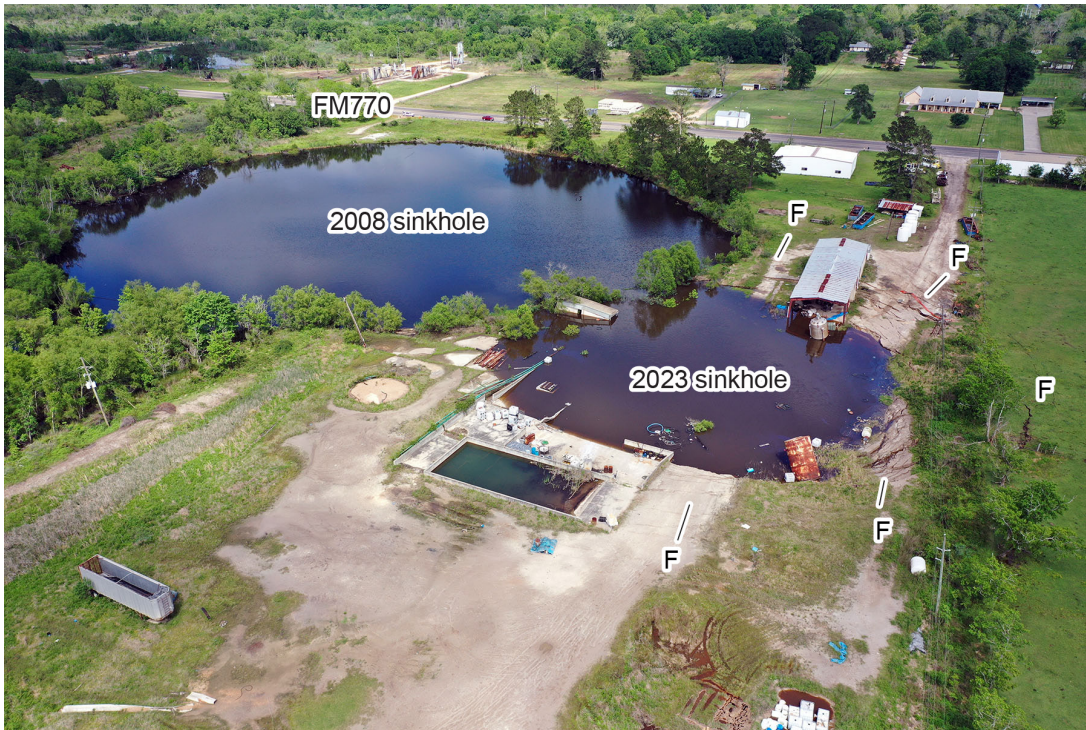
Figure 2. Oblique drone image of the 2008 and 2023 sinkholes, Daisetta, Texas, acquired on April 8, 2023. “F” denotes areas of prominent concentric fissures, scarps, and cracks. View to the east–northeast.

On Sunday, April 2, 2023, a sinkhole formed on the northwestern flank of the Hull salt dome in the city of Daisetta, Texas (fig. 1). This nearly circular sinkhole (figs. 2 and 3), having a water-filled diameter of about 70 m, is located adjacent to the southwestern edge of the larger 2008 Daisetta sinkhole. At the request of the Liberty County Office of Emergency Management, Bureau researchers visited the sinkhole on April 8, 2023 to map concentric fissures and scarps around the new sinkhole; conduct a drone-based, structure-from-motion survey to obtain high-resolution images and construct a post-collapse topographic map of the sinkhole area; measure water depth in both sinkholes; acquire differential GPS elevations for drone imagery georeferencing and elevation-change detection; and use a passive seismic method to estimate the

An aerial survey flown over the 2008 and 2023 sinkhole area on April 8, 2023 using an unmanned drone acquired both oblique (fig. 2) and vertical images of the sinkhole area. Imagery

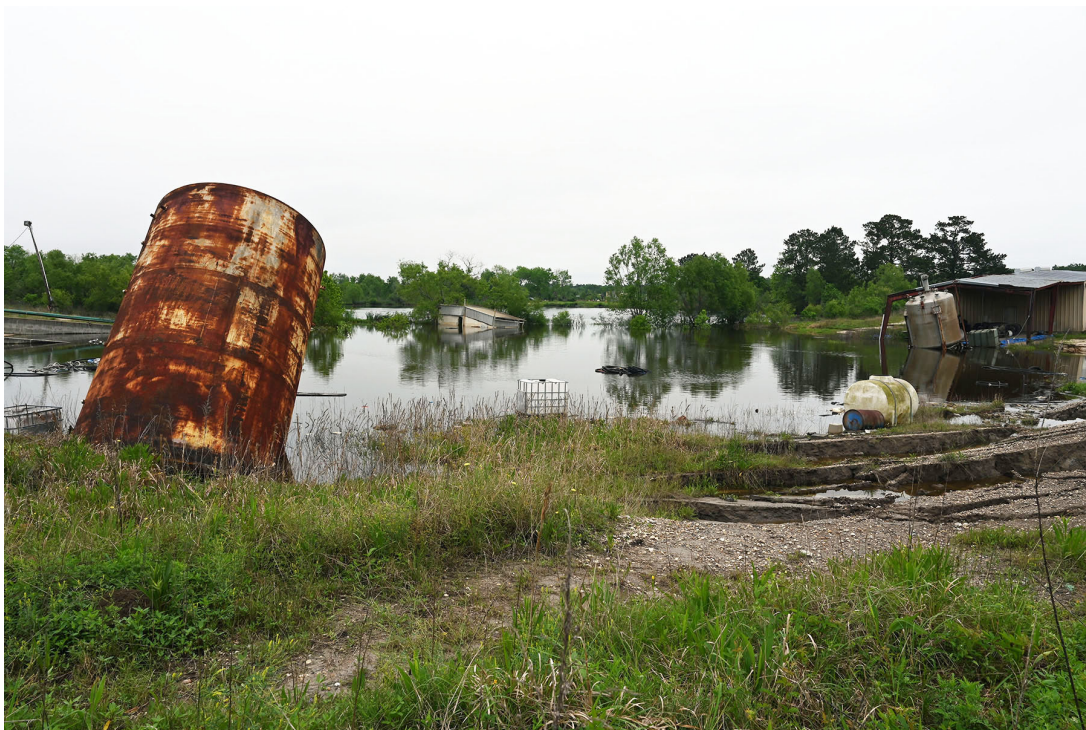
Figure 3. View to the northeast across the 2023 Daisetta sinkhole. The 2008 sinkhole is in the background beyond the tilted yellow-gray building.

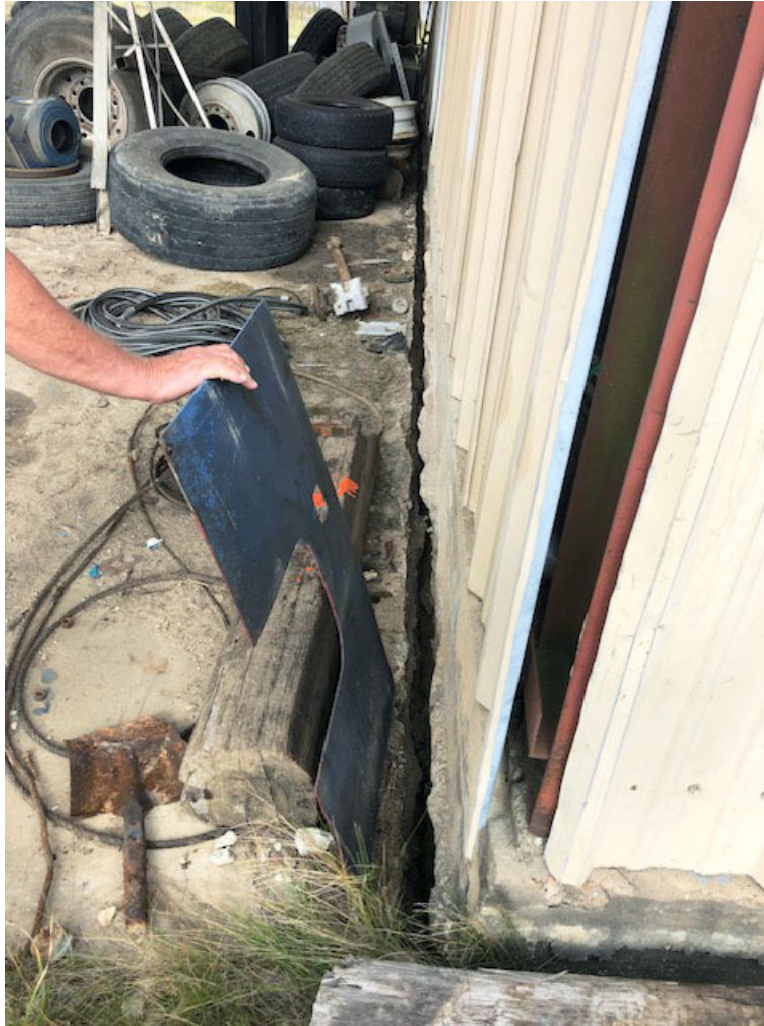
Figure 8. Concrete slab separation beneath a metal-frame building just east of the 2023 collapse area. Photographed on December 10, 2021 by Nat Holcomb. This is the first reported evidence of ground instability within the collapse area of the April 2023 sinkhole.

The sinkhole collapse on April 2, 2023 occurred adjacent to the larger 2008 sinkhole (fig. 6) over a few hours, with collapse reported to have continued intermittently to April 4 (Payne, 2023). Before the rapid collapse phase, the first reported evidence of ground movement at the site included separation of a concrete slab from a metal-frame building on the east side of the new sinkhole, nearly 16 months before full collapse. This feature was reported by a work crew visiting the site in early December 2021 and was confirmed and photographed (fig. 8) by the Liberty County Assistant Fire Marshal during a site visit on December 10, 2021 (N. Holcomb, personal communication, 2023).

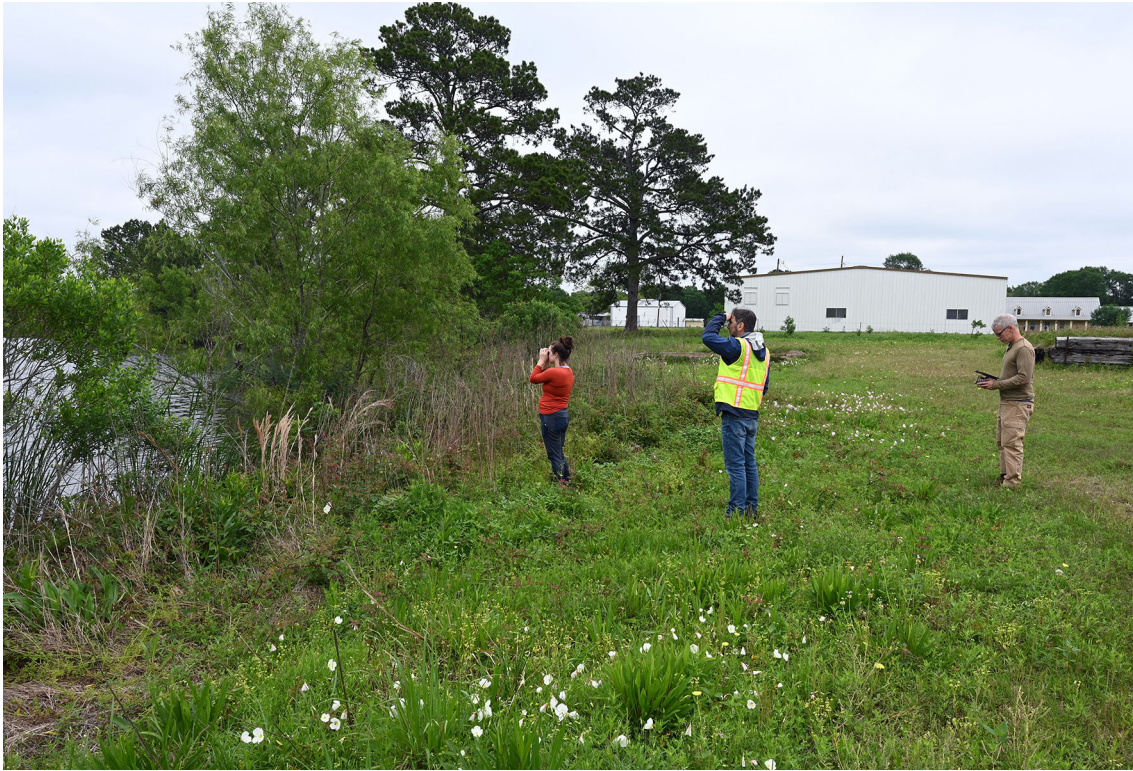
Figure 10. Bureau staff flying the drone to lower a graduated, weighted string into the 2008 Daisetta sinkhole and observing the string to determine water depth (fig. 9).

Drone-based measurements of water depth in the 2008 and 2023 sinkholes employed a graduated, weighted string lowered into the sinkholes by the drone while observers used binoculars (fig. 10) to count string gradations at 1-m intervals as the line entered the water and determine water depth when the weight reached bottom and the line slackened. The maximum water depth in the 2008 sinkhole is 23 m (fig. 9), similar to the depth reported shortly after collapse in 2008 (Howe and Norman, 2009). The maximum water depth measured in the 2023 sinkhole is 9 m (fig. 9).

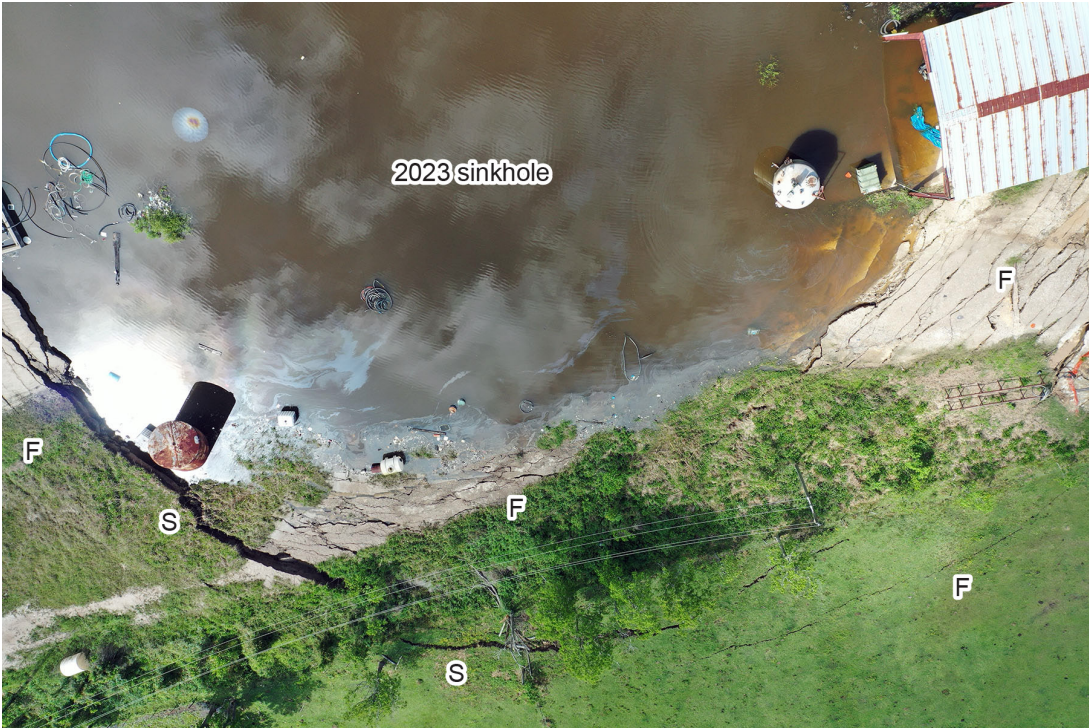
Figure 11. Vertical drone image of the southern part of the April 2023 sinkhole showing concentric fissures (F) and scarps (S) surrounding the water-filled collapse area.

High-resolution drone imagery, ground observations, and GPS measurements documented the presence of scarps (ground opening with vertical offset), fissures (some lateral displacement and ground opening, but little or no vertical offset), and concentric cracks (little displacement) surrounding the water-filled collapse area of the April 2023 sinkhole (figs. 11 and 12). Scarps are more common near the water's edge, grading outward to fissures and finally to subtle cracks with minimal displacement. The zone having scarps, fissures, and cracks extends to between 12 m and about 35 m from the water's edge (fig. 6). Similar features formed during the 2008 collapse. Some of these features around the 2008 sinkhole were submerged as the water level rose, while others remain outside the water-filled part of the 2008 sinkhole. Water level in the 2023 sinkhole equals the current level in the 2008 sinkhole. Oblique views of the two adjacent sinkholes show migration of murky, sediment-laden water from the 2023 sinkhole into the 2008 sinkhole (fig. 13).

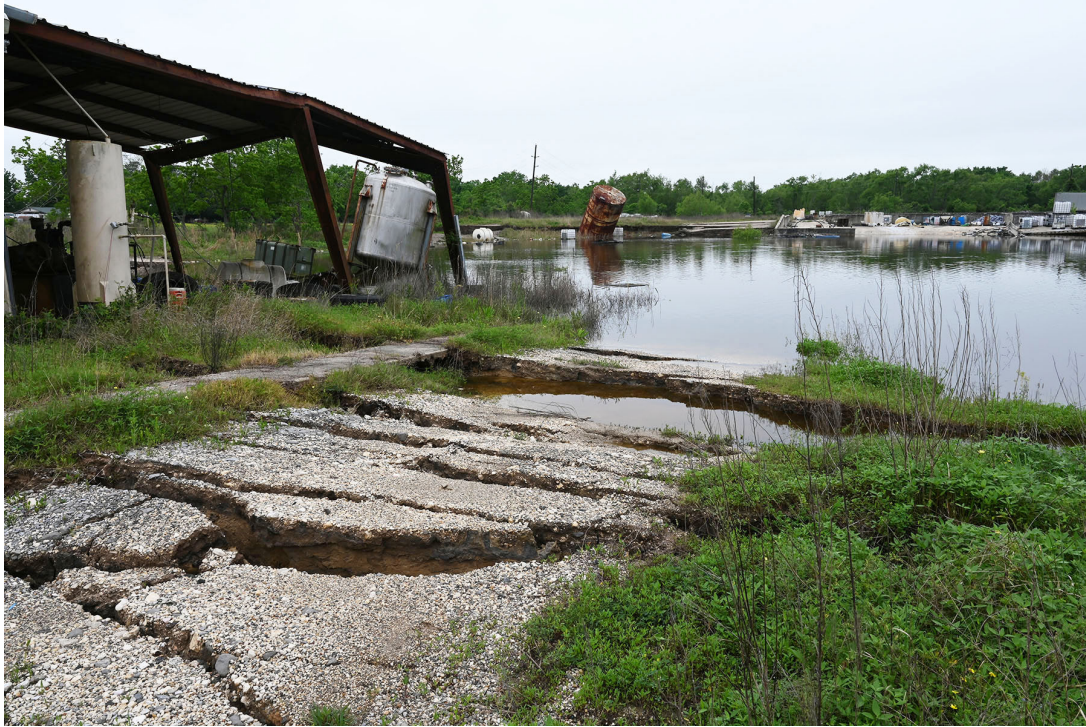
Figure 12. Fissures, scarps, and slump blocks on the east side of the April 2023 collapse area. View to the west across the 2023 sinkhole.

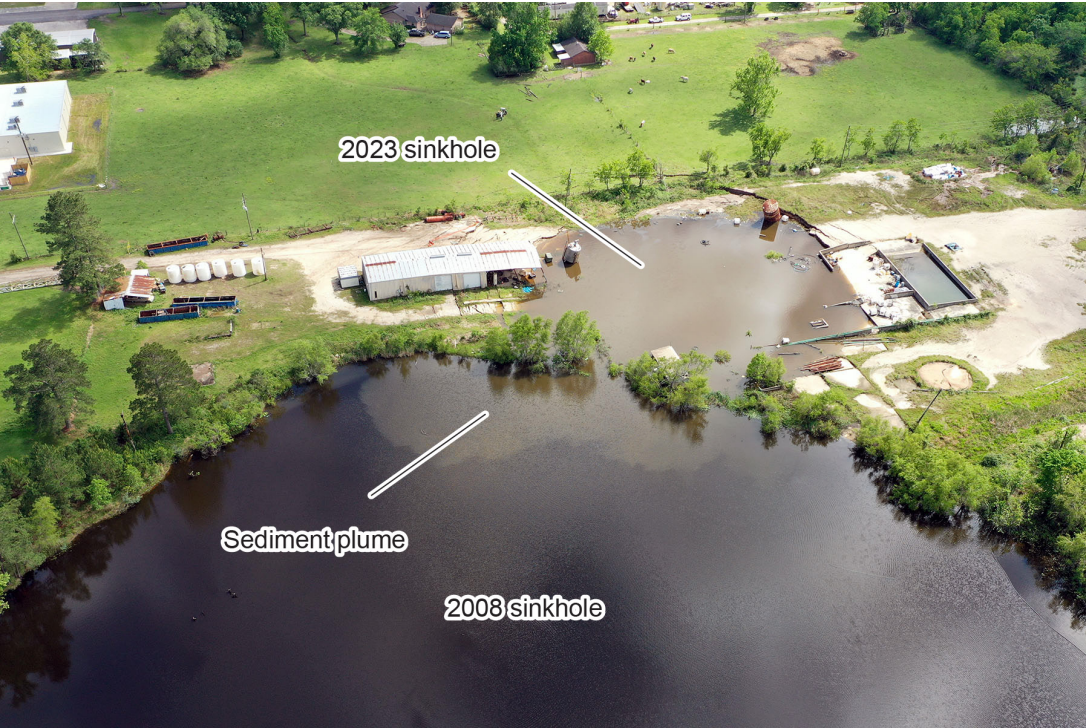
Figure 13. Oblique drone view to the south showing a sediment-laden plume of water flowing from the 2023 sinkhole into the 2008 sinkhole.
