# Impact of Evaporite Dissolution and Collapse on Highways and Other Cultural Features in the Texas Panhandle and Eastern New Mexico

Geological Circular 81-4

1981

Bureau of Economic Geology  
W. L. Fisher, Director  
The University of Texas at Austin  
Austin, Texas 78712

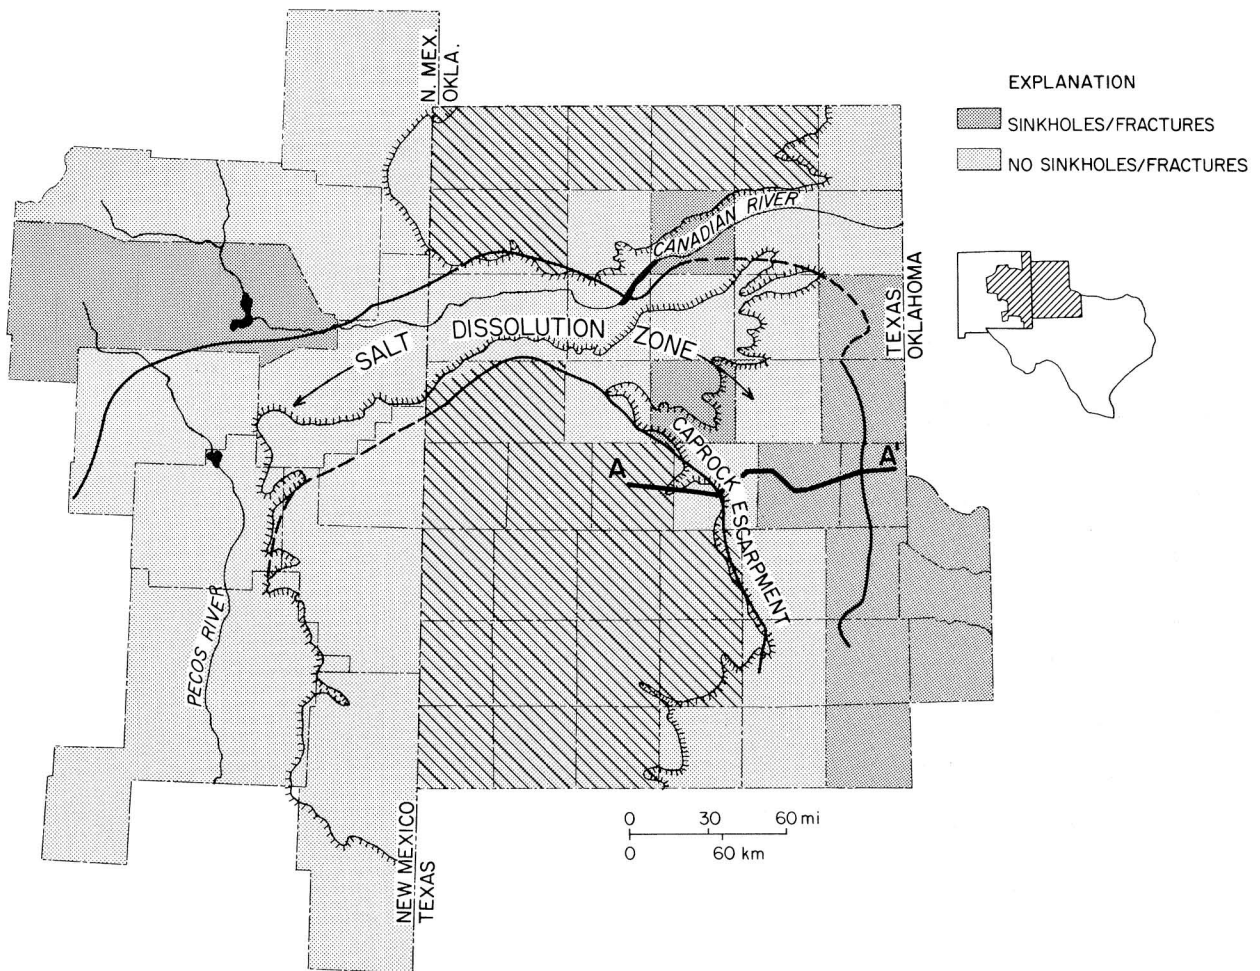
the second questionnaire was to determine if the development of collapse features, fractures, and faults was a recognized problem among those who construct and maintain highways. Results of that questionnaire, shown diagrammatically in figure 6, demonstrate that such features are recognized by highway personnel in 38 percent of those counties that responded positively to the first questionnaire sent to SCS and ASCS personnel. Although highways cover only a small part of the total area, highway personnel recognized that collapse features, fractures, and faults pose a significant problem in maintaining the structural integrity of the highways. Counties in which highway personnel reported such features all lie within the zone of active salt dissolution (fig. 6) and within outcrop belts of gypsum beds of the Permian Blaine Formation (see Barnes, 1967, 1968).

Figure 6. Distribution of collapse features, fractures, and faults that affect highways in the Texas Panhandle and eastern New Mexico, as recognized by highway personnel responding to the second questionnaire. Hachured areas are those counties whose SCS and ASCS representatives did not recognize collapse features, fractures, and faults in the first questionnaire. Correspondingly, these counties were not sent the second questionnaire dealing solely with impacts of collapse features on highways. Salt dissolution lines in Texas after Gustavson and others (1980a) and salt limits in New Mexico after Foster and others (1972). Line of section A-A' refers to figure 4.

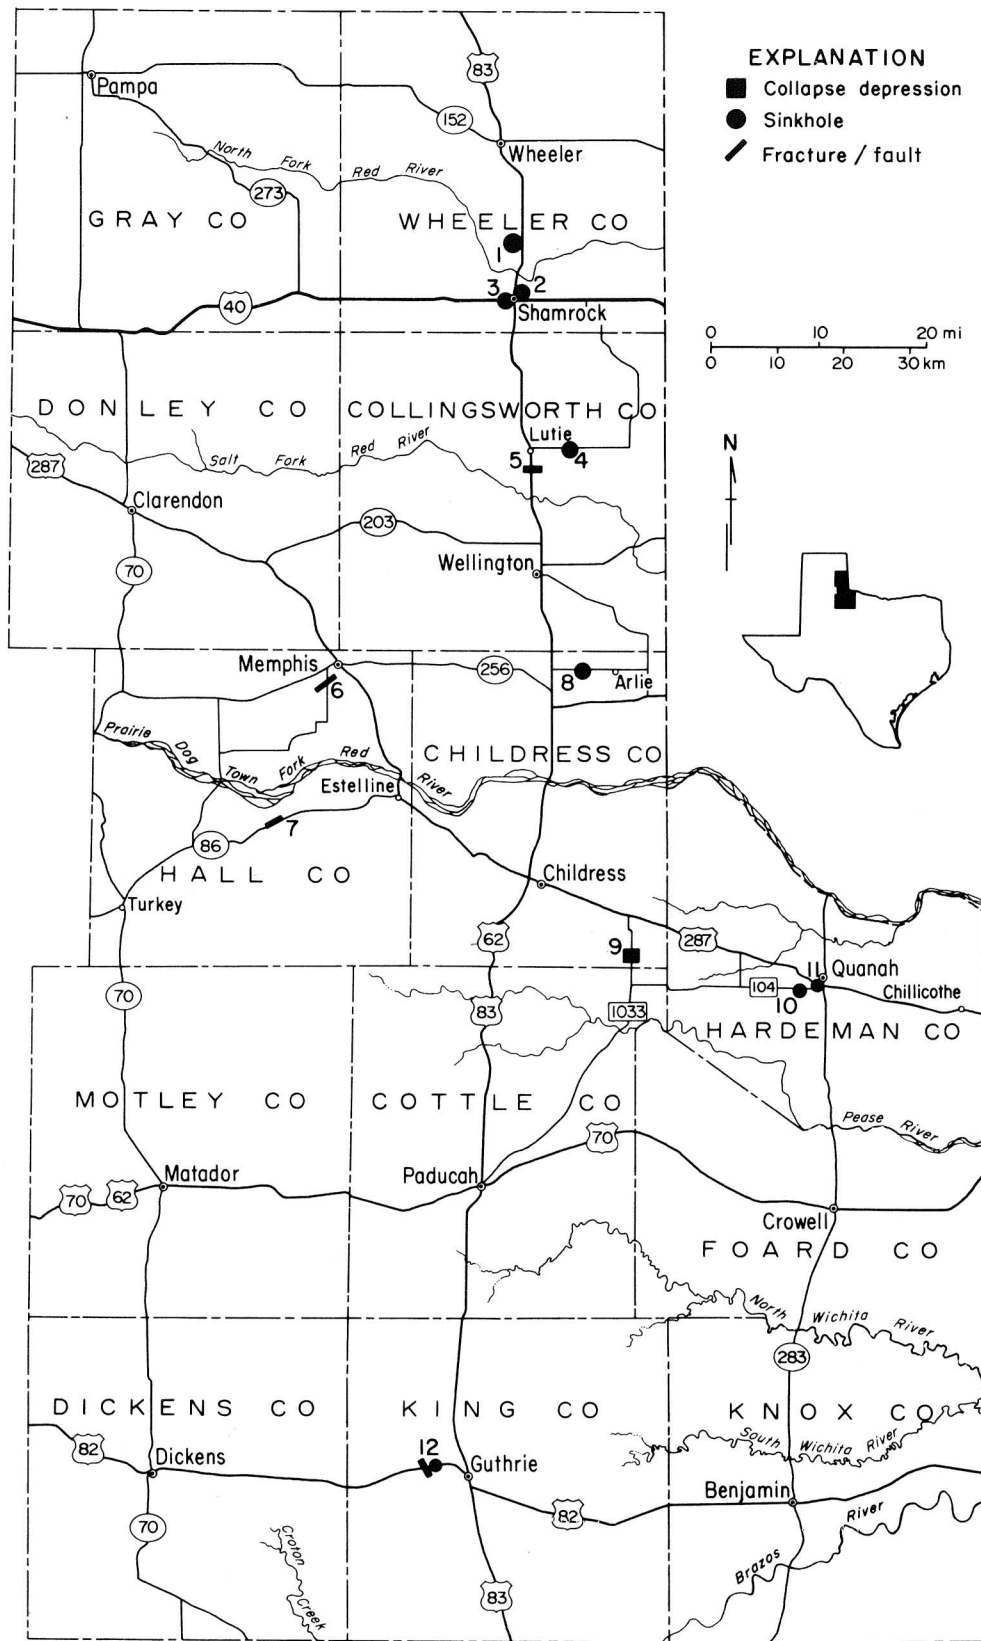
In July 1979, in the northern part of the study area, a sinkhole formed beneath part of U.S. Highway 83 just north of the Interstate 40 overpass in Shamrock, Texas (fig. 7; site 2). The sinkhole opened to a depth of 2.4 m (8 ft) and a diameter of 3.0 to 3.6 m (10 to 12 ft). City water and sewer lines were damaged and part of the northbound lane of U.S. Highway 83 was closed. Gypsum beds of the Blaine Formation are exposed in roadcuts throughout the area, but whether gypsum dissolution is the sole cause of this sinkhole is not known.

A possible collapse depression occurs approximately 4 km (2.5 mi) west of Shamrock on Interstate 40 (fig. 7; site 3). At the point where Interstate 40 passes over Finley Creek, the pavement is depressed about 5 cm (2 inches) over a distance of

Figure 7. Locations of collapse features, fractures, and faults that affect highways within the study area.

In the central part of the study area, a small collapse depression was identified on FM 1033 south of Kirkland, Texas, 1.6 km (1.0 mi) north of the Childress-Cottle county line (fig. 7; site 9). Diameter of the feature is about 6 m (20 ft); about half of the depression affects the pavement surface. Several generations of road patches attest to the fact that collapse has occurred over several years. Repairs to this section of the highway have been made regularly since 1966. Within the collapse depression, a smaller sinkhole in the highway borrow ditch collapses periodically and must be filled (fig. 8). The effect on the highway itself, however, is mainly from the collapse depression.

larger sinkholes in gypsum bedrock occur along Texas Highway 114/U.S. Highway 82, 4.8 km (3 mi) west of Guthrie, Texas (fig. 7; site 12). Two holes with depths between 5.2 and 6.4 m (17 and 21 ft) have developed there within the last 10 years. A third sinkhole began as a very small hole in the borrow ditch and eventually expanded under the highway along a N 30° W trend. Subsidence was sufficiently rapid to require repairs at least twice a week for the first year and a half after collapse began. A linear trend like that displayed by this sinkhole is unusual. In this case the trend may actually comprise a much larger sinkhole that collapsed first where the surface was not supported by highway pavement.

Another major impact of dissolution and collapse on highways is faulting. The best example of faulting occurs along FM 2639, 19 km (12 mi) west of Estelline in Hall County, Texas (fig. 7; site 7). Here, six faults trending N 25° E to N 50° E were recognized by displacement along the faults measuring from 1 to 4 cm (0.4 to 1.6 inches). Although only a few inches wide when formed, the fault plane (fig. 10) was 1.5 m (5 ft) deep. Repairs have been necessary on the road about three times per year since the fault appeared in 1979. Similar faults have been recognized near Memphis, Texas (fig. 7; site 6), and 9.6 km (6 mi) south of Lutie, Texas (fig. 7; site 5). The Lutie fault plane was nearly 0.9 m (3 ft) deep and the fault trace trended almost east to west across the northbound lane of U.S. Highway 83. It has since been filled and has not recurred.
