GEOLOGICAL
CIRCULAR **74-2**

SHORELINE CHANGES ON GALVESTON ISLAND
(BOLIVAR ROADS TO SAN LUIS PASS)

AN ANALYSIS OF HISTORICAL CHANGES
OF THE TEXAS GULF SHORELINE

BY ROBERT A. MORTON

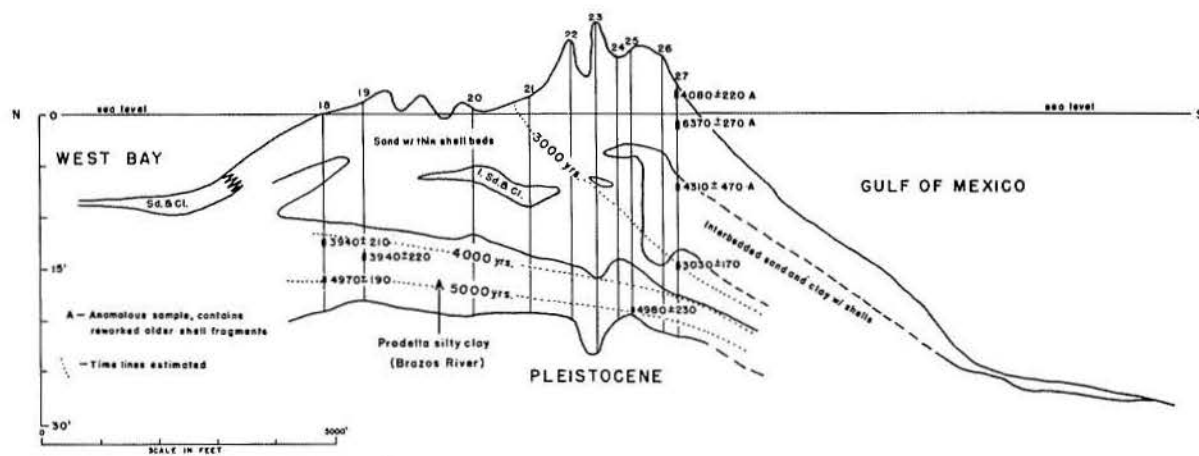
RADIOCARBON DATES OF SHELL BEDS, GALVESTON ISLAND WEST LINE

Figure 5. History of the development of Galveston Island based on radiocarbon dating. After Bernard and others (1959).

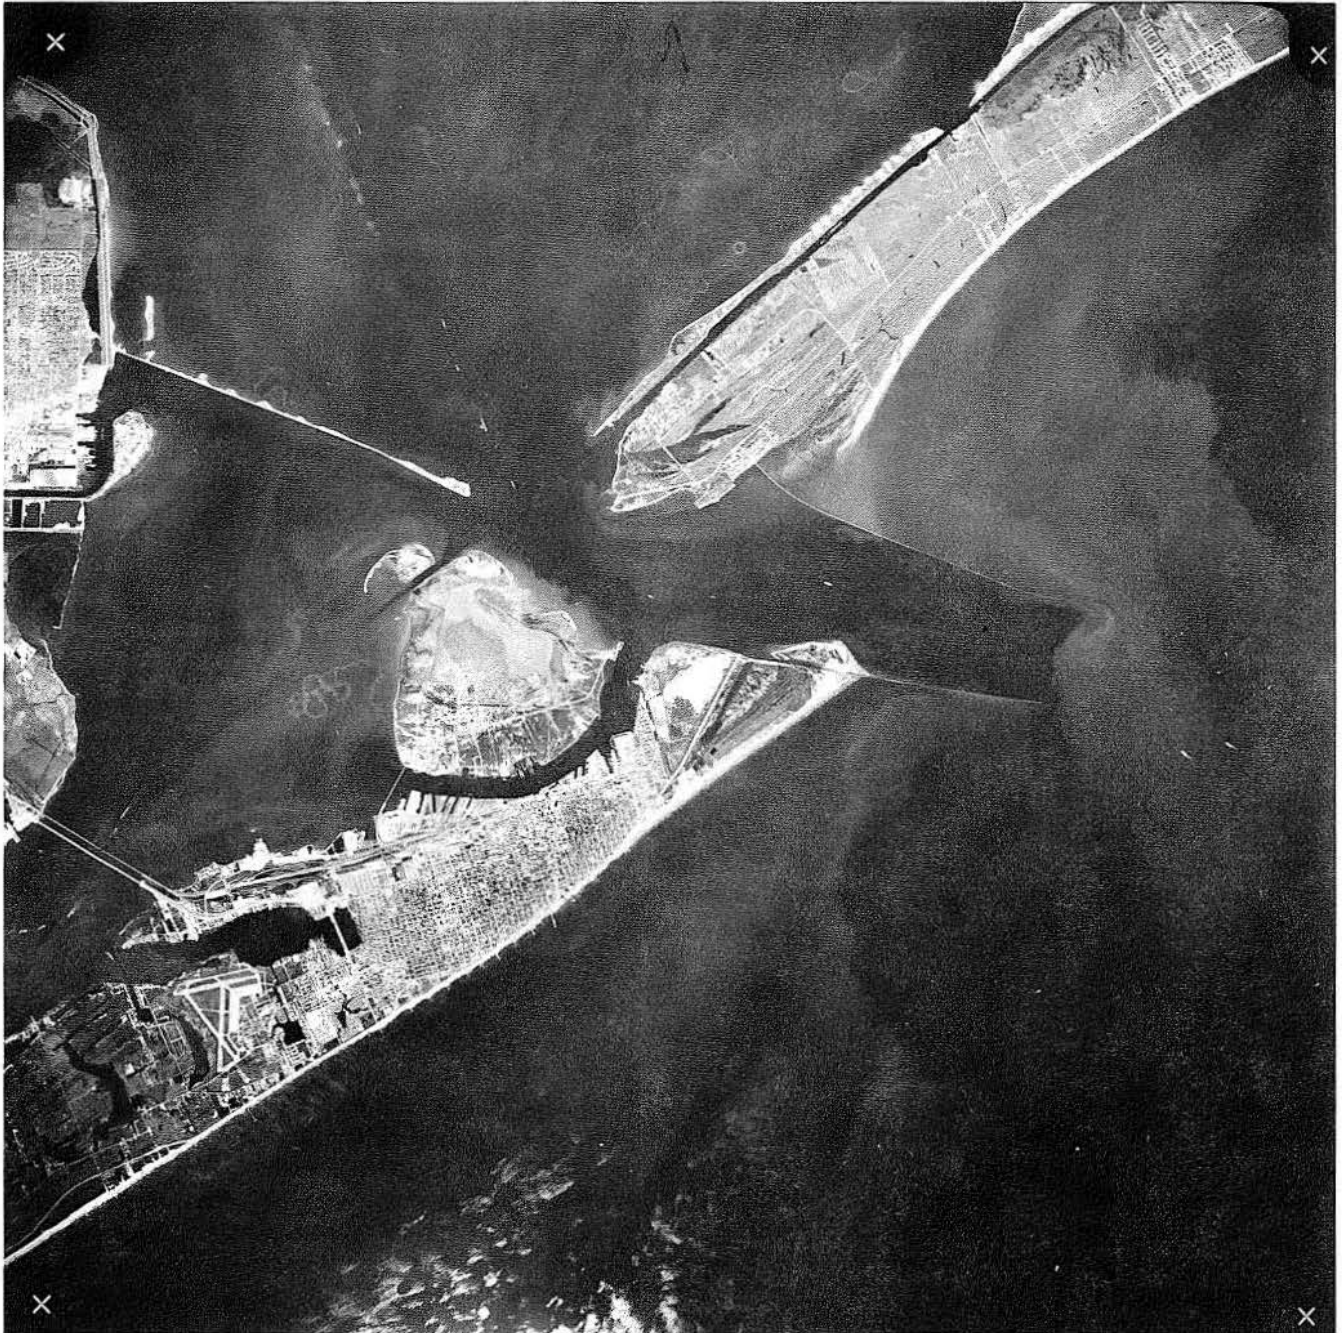
Figure 10. Littoral drift in vicinity of Bolivar Roads and Galveston Harbor jetties.

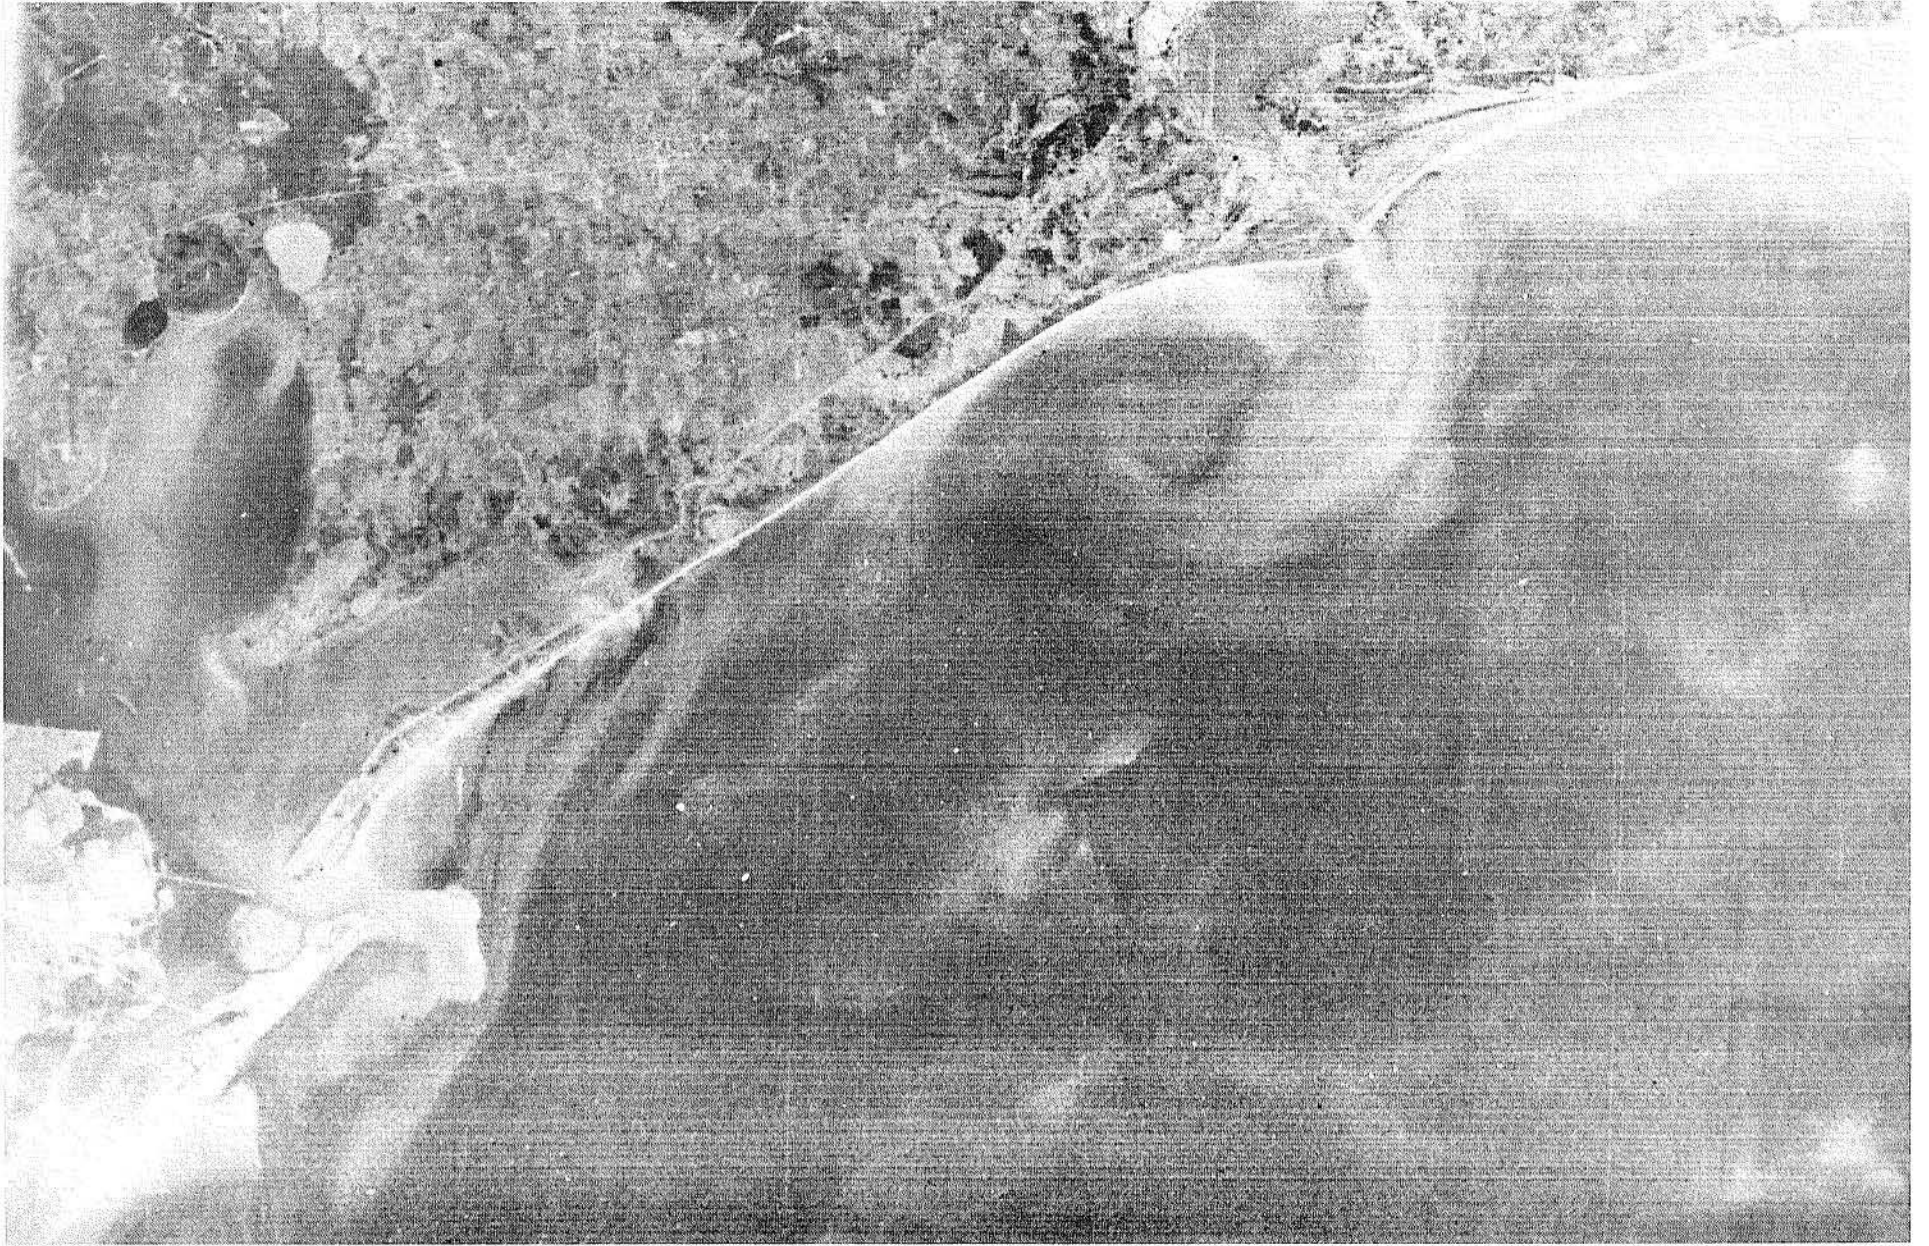
Figure 11. Littoral drift along upper Texas Coast (Sabine Pass-Galveston Island).
