# FORMATION OF THE WINK SINK, A SALT DISSOLUTION AND COLLAPSE FEATURE, WINKLER COUNTY, TEXAS

Robert W. Baumgardner, Jr., Ann D. Hoadley, and Arthur G. Goldstein

The University of Texas at Austin • Austin, Texas 78712 • 1982

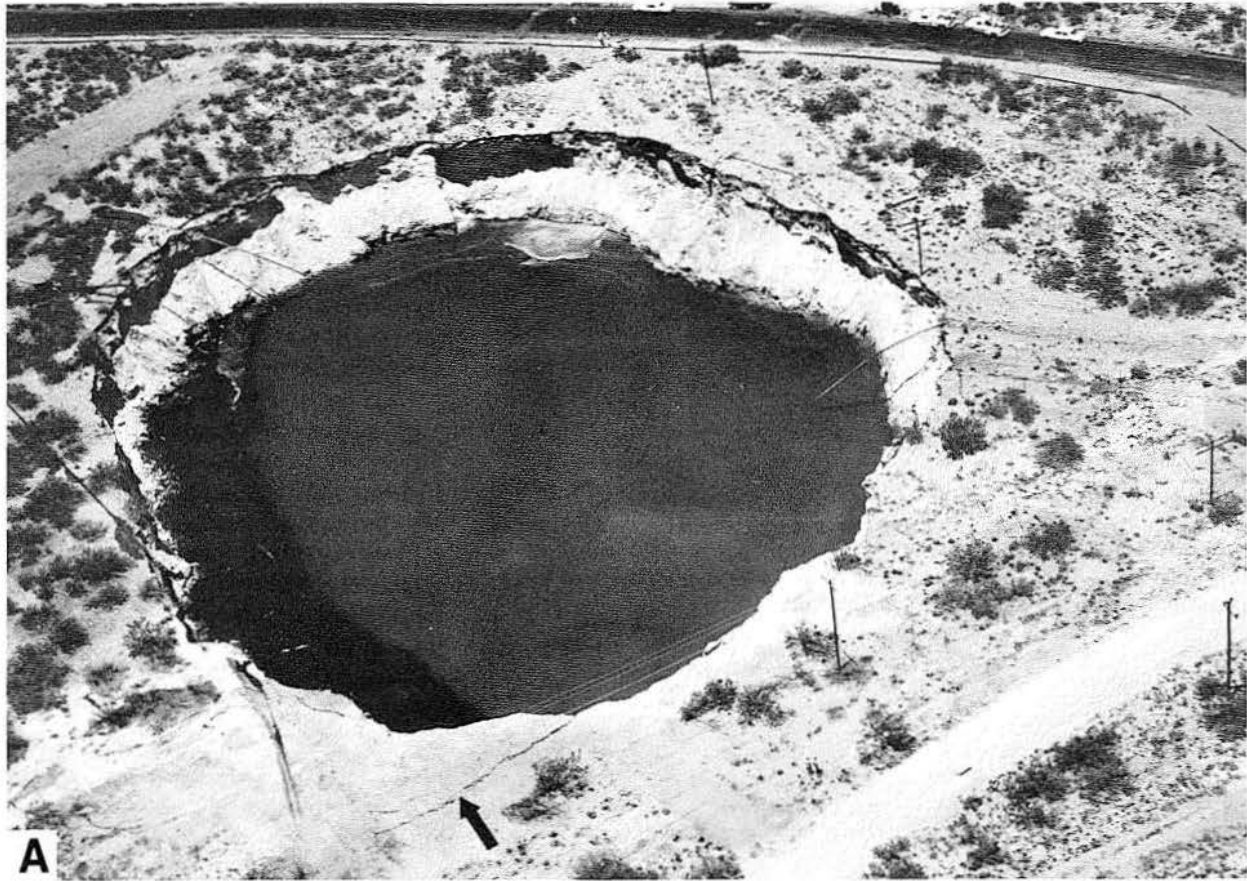
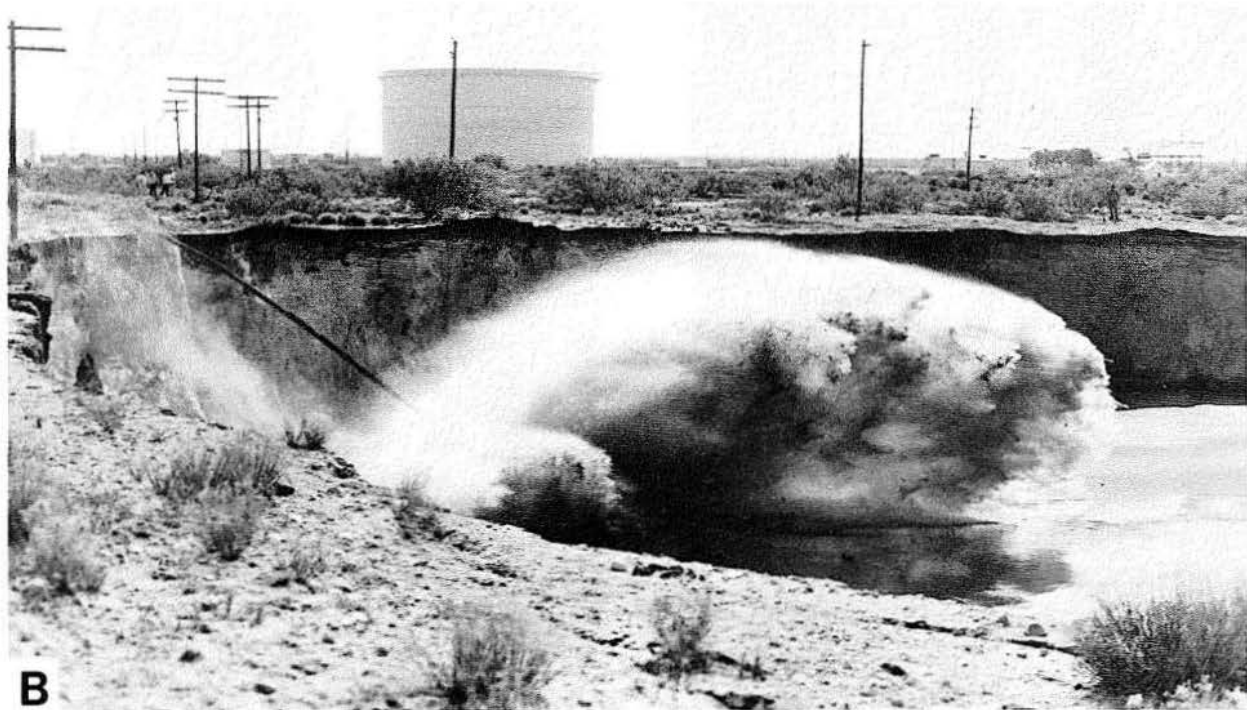
Figure 1. Aerial and ground-level oblique photographs of the Wink Sink. (A) Oblique aerial photograph, June 5, 1980; north is to upper right. Depth to water surface is about 33 ft (10 m). Annular tension cracks surround the hole. A tangential crack (arrow) on the southeast side of the hole marks the eastern boundary of a zone of continued subsidence. All photographs, except where noted, are by Robert W. Baumgardner, Jr. (B) Slab failure with block collapsing into the sinkhole, June 3, 1980. Photograph by John Weaver, reprinted courtesy of Winkler County News.

On June 3, 1980, at about 9 a.m., a Harvard Construction Company crew was inspecting a Gulf Oil Company brine pipeline on the east side of section 41, block B-5, Public School Lands (PSL) survey, in Winkler County, Texas. The pipeline was leaking from a collar joining two sections of 24-inch-diameter (61-cm) pipe (Juan Garcia, Harvard Construction Co., personal communication, September 28, 1980). Splashing water attracted one crew member to a 20-ft-wide (6-m) hole in the ground about 100 ft (30 m) west of the pipeline. Large blocks of earth were collapsing into the hole, throwing water 30 ft (9 m) into the air. By noon, the diameter of the hole was about 100 ft (30 m). Rapid expansion of the oblong cavity ceased by the next morning, when its longest (east-west) dimension was about 360 ft (110 m) (fig. 1A).

Blocks up to 30 ft (9 m) long continued to fall into the hole at irregular intervals for several weeks (fig. 1B). Annular cracks that surround the hole extend up to 290 ft (88 m) from the southern edge. A large area bordering the south rim of the sinkhole subsided about 10 ft (3 m) relative to the north side within the first 3 days of movement (fig. 2A, B). This small grabenlike depression is bounded on the east and west by fissures up to 60 ft (18 m) long that are tangent to the hole (fig. 3A). Subsidence has been accompanied by faulting and lateral movement of the depressed block, as shown by abundant tension fractures (fig. 3B).

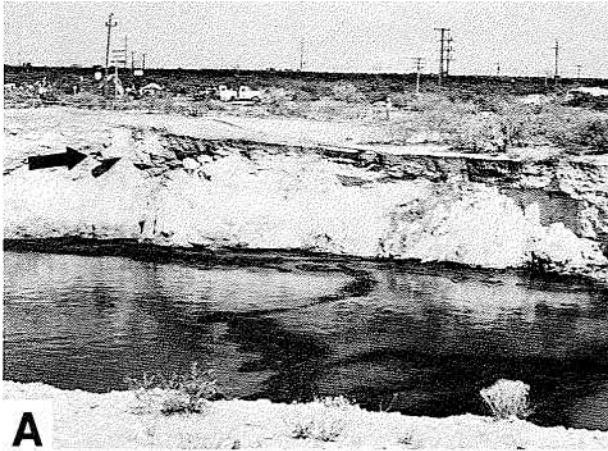
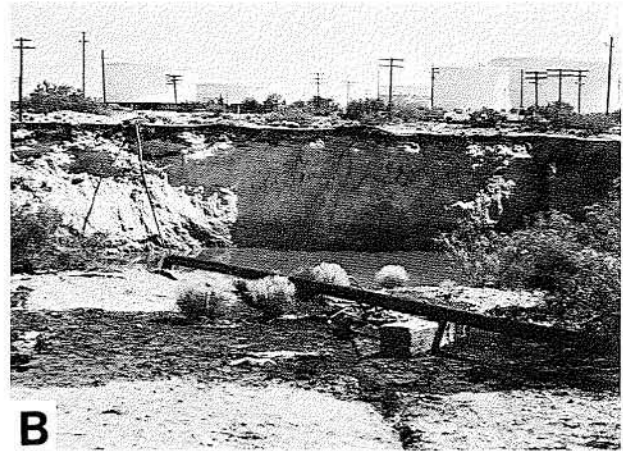
Figure 2. Local setting of the Wink Sink. (A) South side of the Wink Sink, June 5, 1980; view is to southeast from the northwest side of the hole. Area to the right (west) of brine pipeline (arrow) has subsided about 10 ft (3 m), producing a noticeable sag. (B) Wink sinkhole, June 5, 1980; view is to east from the southwest side of the hole. Pipeline in foreground was not in use when sinkhole formed. Oil pipeline on far side of sink was in use and had to be rerouted after being broken. Oil storage tanks in background are operated by Shell Oil Company.

Development of the sinkhole had little effect on oil field operations. Workmen cut and rerouted a Shell Oil Company pipeline 6 inches (15 cm) in diameter that carried crude oil to storage tanks 1,000 ft (305 m) northeast of the sinkhole (fig. 2B). The brine pipeline originally being inspected by the Harvard Construction Company maintenance crew was broken by the expanding hole (fig. 2A). As a result, the oil wells producing the brine had to be shut down.

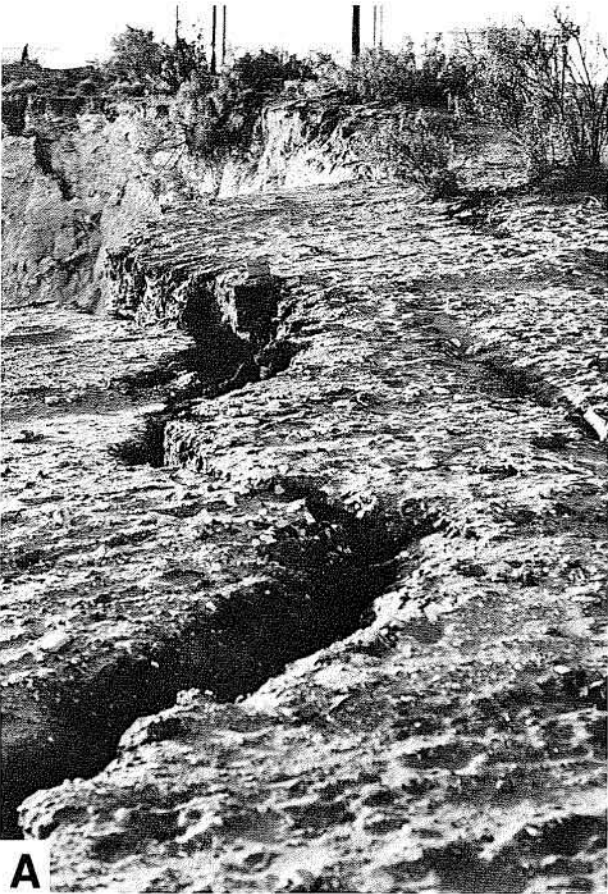
Figure 3. Tension fractures near the Wink Sink. (A) Tangential surface fracture on east side of the subsided area, July 10, 1980; view is to north. Vertical displacement next to fieldbook (upper center of photograph) is about 18 inches (46 cm). This is the same crack marked by the arrow in figure 1A. (B) East-west tension fracture on south side of Wink Sink, November 18, 1980; view is to east. Maximum width of crack (24 inches [61 cm]) is a result of slumping. Block on left has moved only 6 inches (15 cm) to the left (north), relative to block on the right, as shown by width of crack adjacent to fieldbook.

Subsidence was accompanied by cracking of the ground surface (fig. 3) as subsiding areas closer to the hole separated from peripheral areas. Cracks are most abundant south of the sinkhole, but occur on all sides of the sink and cover an area 740 ft (225 m) in diameter. Separation along the cracks measures as

much as 6 inches (15 cm), although soil slumping from edges of the cracks increases the apparent width to as much as 24 inches (61 cm) (fig. 3B).

Tension fractures concentric with the sinkhole have widened more than tension fractures tangent to the sinkhole, as a photograph of the area southeast of the sink illustrates. The crack shown in figure 3A did not widen between June 27 and November 18, 1980, although one concentric crack monitored during the same period increased from a width of 3.5 inches (9 cm) to 5.6 inches (14 cm).

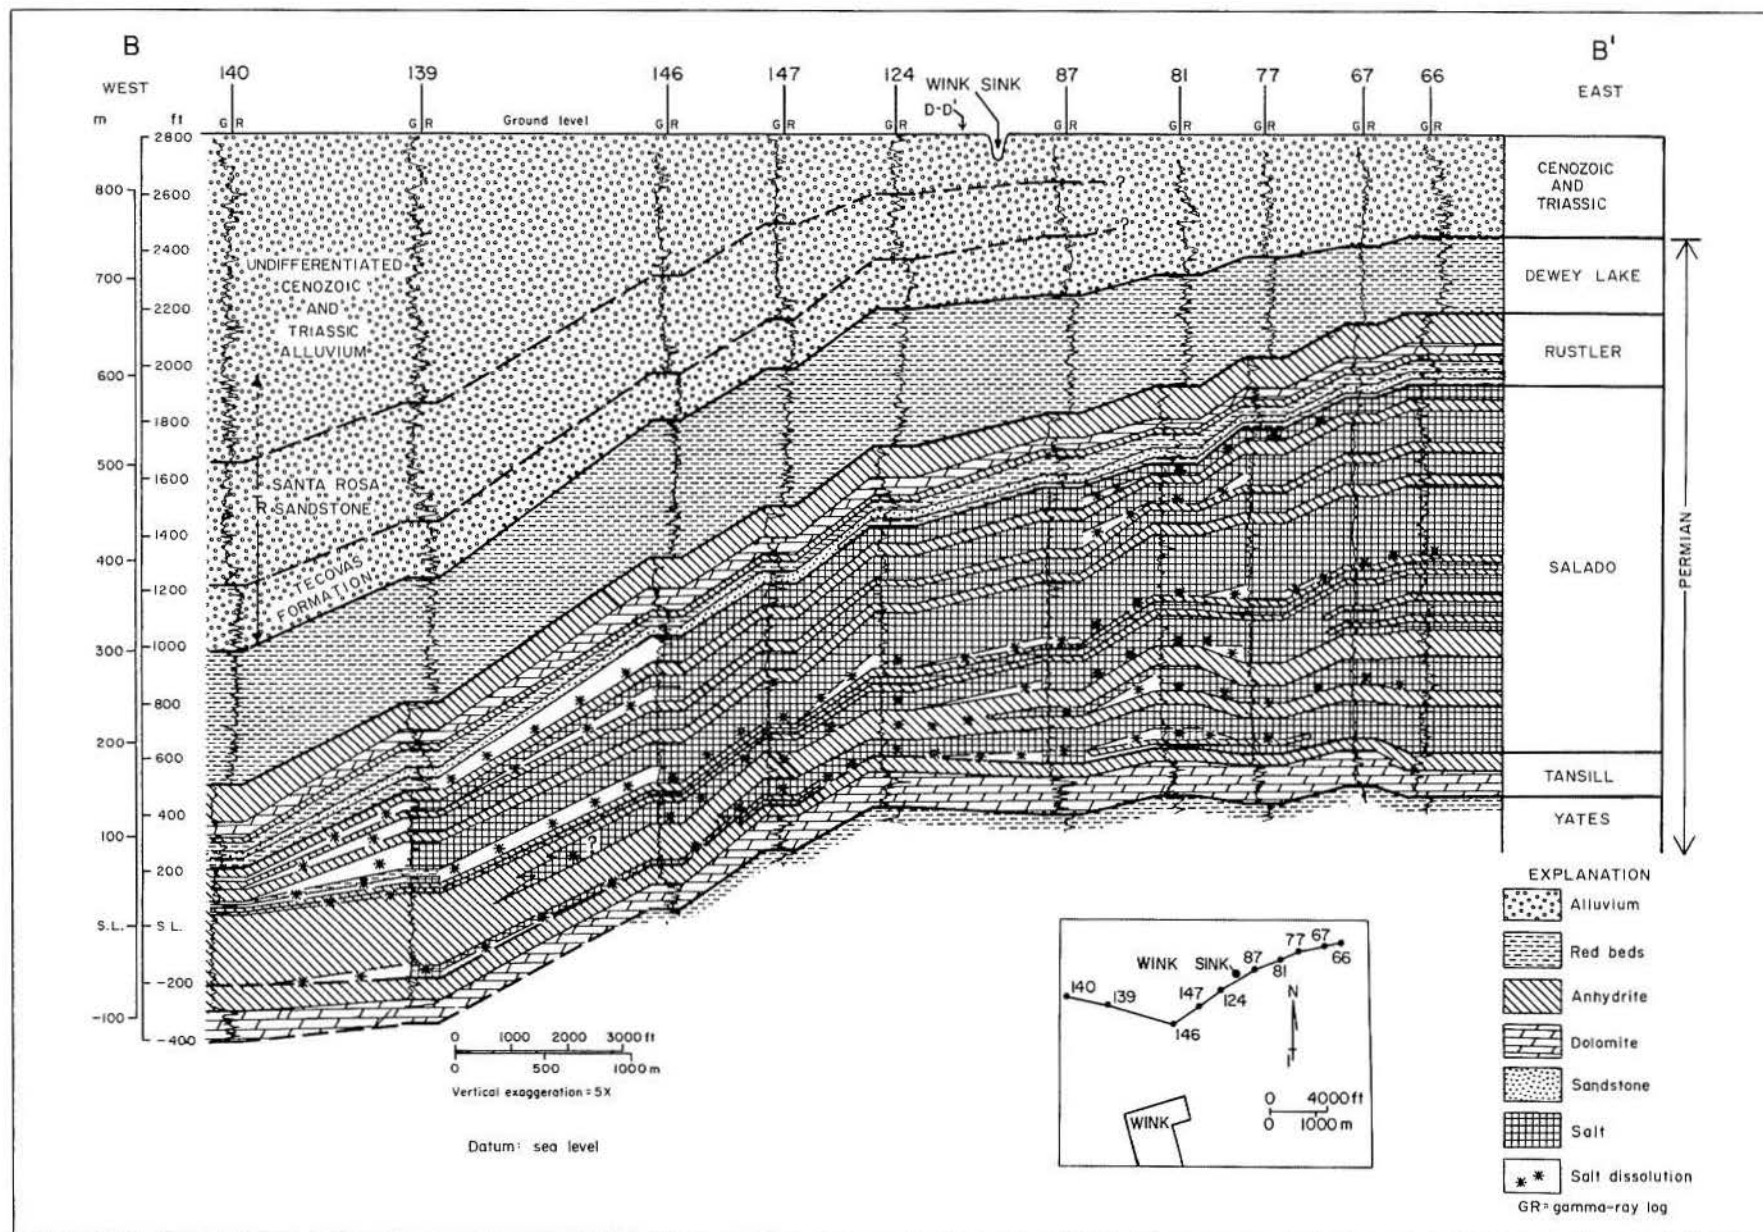
Figure 7. Local east-west cross section B-B' showing salt dissolution zones in Salado Formation. Westward decrease in elevation of Permian and Triassic strata above the Salado is caused by dissolution and collapse in the salt-bearing section. Upper and lower contacts of Triassic Santa Rosa Sandstone are approximate. Inset shows location of cross section; line of section also shown on figures 8 through 10. See figures 15 and 16 for more detail.

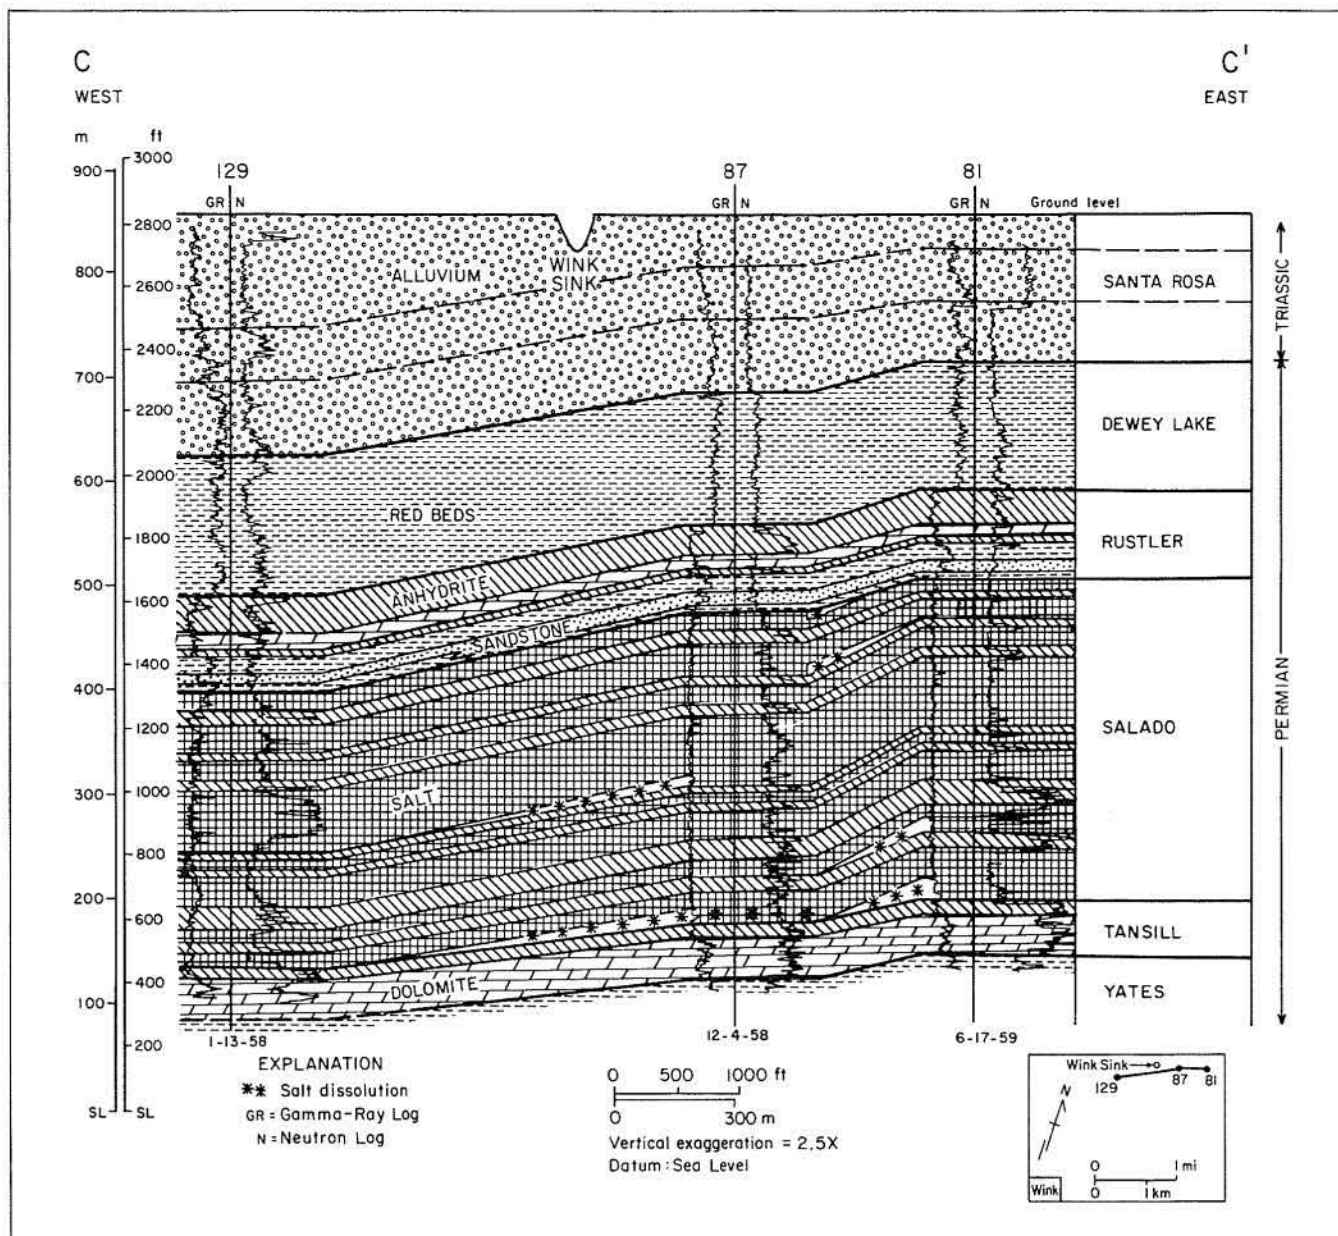
Figure 15. Detailed east-west cross section C-C' at site of Wink Sink. Salt dissolution zones occur at several levels and can be traced laterally by noting decrease in salt thickness between adjacent anhydrite beds. Note two dissolution zones beneath Wink Sink. Number above each well refers to appendix B. Date below each well indicates date of well logging. Elevations of top and base of Santa Rosa Formation approximate. Inset shows location of line of section.

Near the sink, cross section D-D' (fig. 16) is approximately parallel to the axis of the dissolution trough. The same three anhydrite beds observed on cross sections B-B' and C-C' (figs. 7 and 15) occur in the upper 380 ft (116 m) of the Salado Formation, and dissolution zones are associated with all three beds. Net salt decreases southward from 600 ft (183 m) in well 10 to 415 ft (126 m) in well 109, then increases to 710 ft (216 m) in well 269 (table 2). No progressive change in salt thickness is recognized parallel to the dissolution trough, but cross section D-D' reveals that dissolution zones extend beneath the Wink Sink.
